LUX Fireplace Inspections

Wednesday, June 12, 2024
Vincent Marshal
1616 Linda Rosa
Los Angeles, California 90041

Living Room

Living Room Mason Fireplace

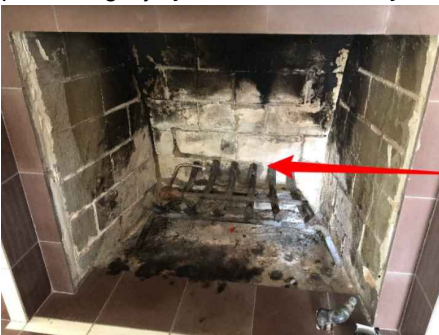
FIREPLACE SCREENS**5: Fireplace Screens: Potential Hazard****Missing Screen Set**

While inspecting your fireplace, we noticed your fireplace does not have a screen set posing a potential fire hazard and health/safety hazard. Screen sets prevent embers from exiting the fireplace and contacting combustible material such as wood floors and/or carpet. In addition, screen sets prevent family animals and young children from accessing the firebox preventing injury. We recommend you have a new screen set installed.

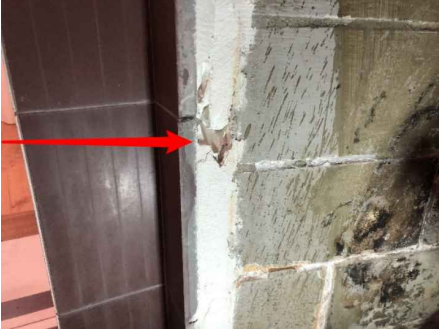
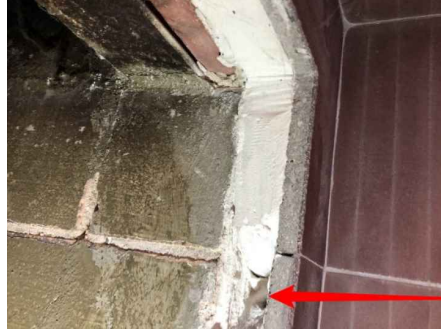
6: Combustion Chamber/Firebox: Potential Hazard

Gap(s) Between Firebox And The Surrounding Facing Material

There is combustible paint in the firebox which has filled gaps that were identified between the firebrick of the firebox and the surrounding facing material allowing for the transference of heat to combustible material posing a drafting and fire hazard. In addition, these gaps can affect the proper drafting and flow of smoke and monoxides through the system. It is recommended you have a qualified professional seal these with high temperature cement.

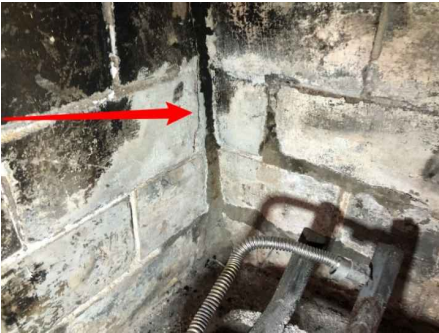
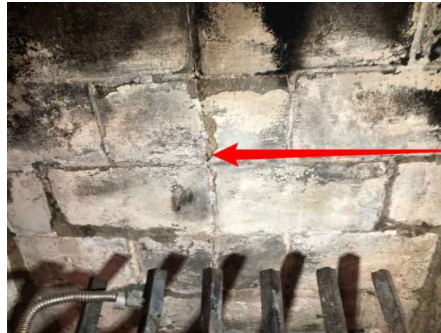
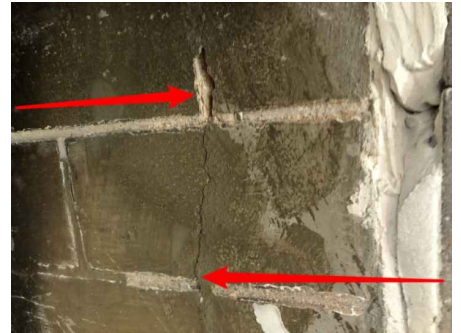
7: Combustion Chamber/Firebox: Potential Hazard

Mortar Joint Gaps In Firebox

In the course of our inspection, we noted that the mortar joints between the firebricks inside the firebox have eroded away producing gaps, allowing for the transference of heat to combustible material posing a potential fire hazard and drafting hazard. We recommend not using the fireplace until corrective action has been completed by grinding out any weakened or missing pieces of mortar in the firebox and repairing the mortar joints with high temperature cement.

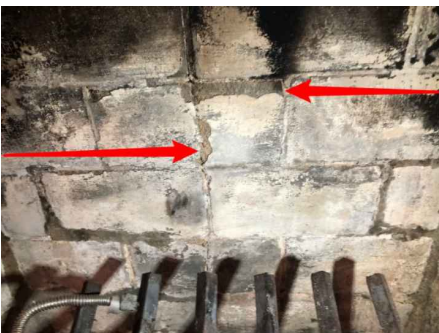
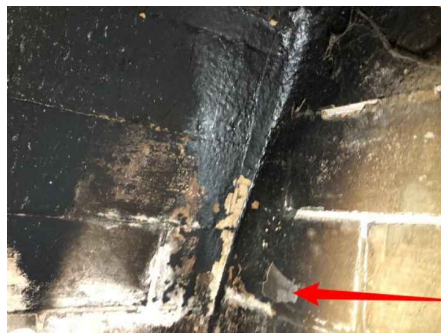
8: Combustion Chamber/Firebox: Potential Hazard

Spalling Bricks

Some of the bricks in your combustion chamber are spalling indicating that water is accessing the flue system. Spalling is the deterioration of brickwork and a common problem that occurs when moisture penetrates the bricks and mortar. The moisture inside the brick expands and contracts causing the bricks to break down, crack and crumble. If this problem goes unresolved, it can compromise your firebox. It is recommended that remove the damaged bricks and replace them new firebrick if needed.

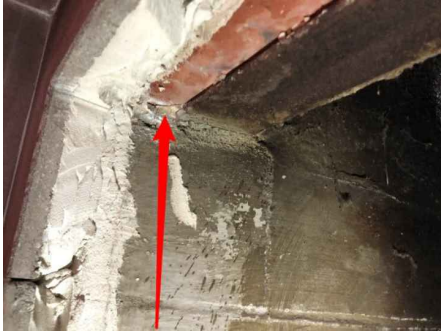
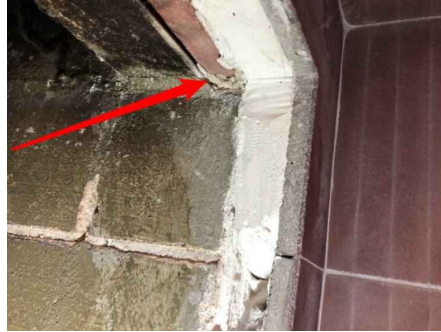
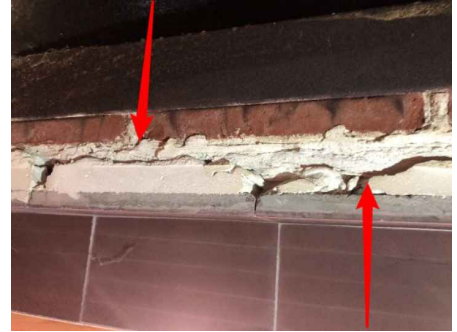
9: Lintel Bar: Potential Hazard

Gaps at Lintel Bar

The lintel bar is at the top of the firebox's opening. During our inspection, we found gaps in the mortar joints at the lintel allowing for the transference of heat to combustible material posing a potential drafting and fire hazard. We recommend not using the fireplace until a qualified professional repairs this area by filling these gaps with high temperature cement.

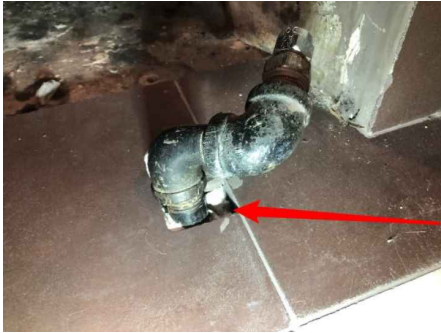
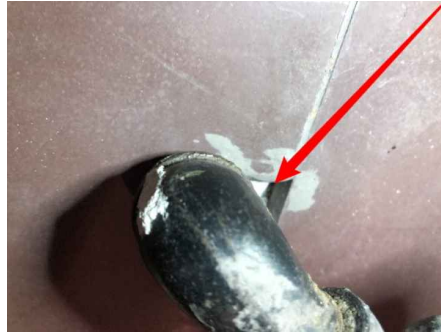
10: Gas Line: Potential Hazard

Gap Around Gas Line

There is a gap around the gas line's entry point into the firebox allowing for heat to transfer to combustible framing and effecting the proper drafting and flow of smoke and monoxides through the system. We recommend that a qualified professional seals the gap around the gas line with high temperature cement or high temperature caulking before the fireplace is used again.

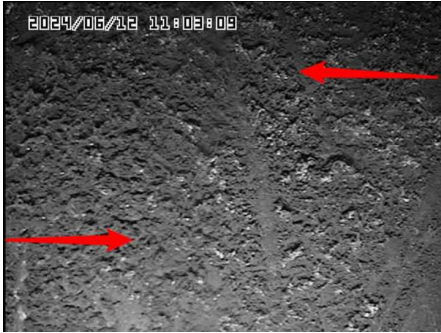
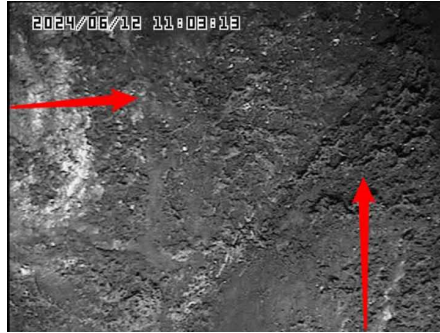
11: Smoke Chamber: Potential Hazard Soot Buildup

When inspecting the smoke chamber, we noticed a buildup of soot. Soot can decrease the size of the smoke chamber choking the chimney which can allow for smoke to backdraft into the living area. Chimney fires and/or flue fires can occur as a result of soot and creosote within the smoke chamber. One of the primary reasons to have an annual chimney inspection is to determine whether creosote has built up to the point of making a chimney fire a real threat. We recommend that you have the chimney swept. It may be necessary to a chemical treatment to remove the soot. After the sweep the smoke chamber should be inspected.

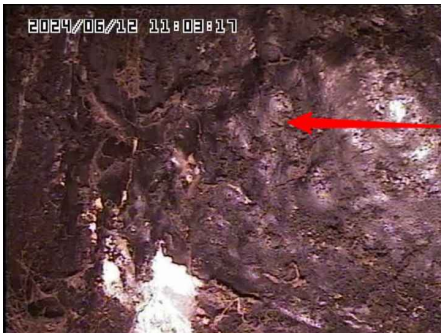
12: Smoke Chamber: Potential Hazard Creosote Sheen

When inspecting the smoke chamber, we noticed sheen of creosote after your sweep. Chimney fires and/or flue fires can occur as a result of soot & creosote within the smoke chamber. One of the primary reasons to have an annual chimney inspection is to determine whether creosote has built up to the point of making a chimney fire a real threat. We recommend that you purchase Creosote Remove. There are multiple different products that can be used. ACS Anti-Creo-Soot Liquid is available on Amazon

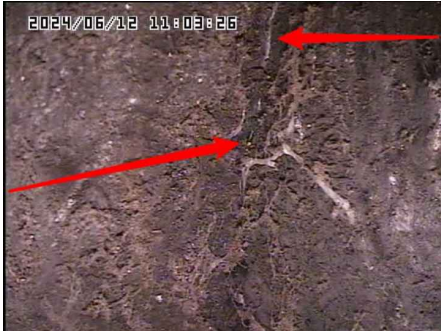
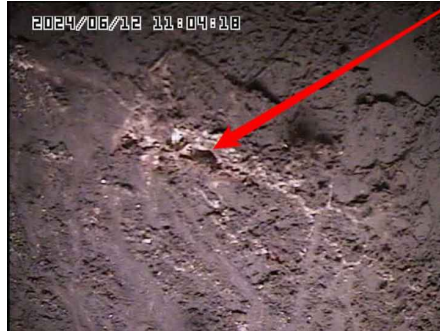
**13: Smoke Chamber: Potential Hazard
Gaps In Smoke Chamber**

In the course of our inspection within the smoke chamber, the area above the damper, we noticed openings or gaps in the chamber. These gaps allow for the transference of heat to combustible materials posing a fire hazard. In addition, these gaps may prevent the smoke chamber from properly and safely funneling flue gases and condensates from the firebox to the chimney posing a drafting, fire and health/safety hazard potentially allowing for carcinogens and monoxides to enter the living area. We recommend repairing this area as soon as possible by coating the smoke chamber with high temperature cement or by rebuilding a new smoke chamber.

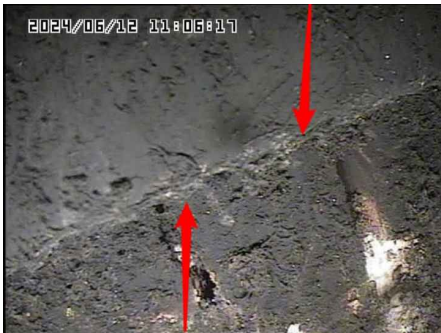
**14: Smoke Chamber: Potential Hazard
Gaps At The Transition To The Flue Liner**

When inspecting the transition point of the smoke chamber to the flue liners we found openings or gaps. These gaps may prevent the system from properly and safely funneling flue gases and condensates out the chimney. In addition, this condition allows for the transference of heat to combustible material. These conditions pose drafting, fire, and health/safety hazards. We recommend repairing this area as soon as possible by coating/sealing the transition point from the smoke chamber to the flue liners with high temperature cement.

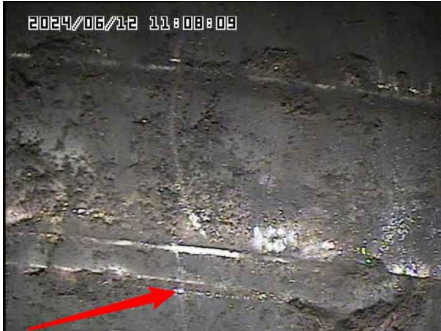
**15: Flue Liners: Potential Hazard
Improper Rebuild Of Chimney**

While examining the flue liners of your chimney we found that your chimney was improperly rebuilt not conforming to the City of Los Angeles Department of Building and Safety (LADBS). There is no bond beam, adapter cone, or anchor plate. Your chimney needs to be rebuilt properly from the mason top of the chimney. If you are in Los Angeles County the Information Bulletin on "RECONSTRUCTION AND REPLACEMENT OF EARTHQUAKE DAMAGED MASONRY CHIMNEYS" put forward by The City of Los Angeles Department of Building and Safety must be followed. The information bulletin put forward by Los Angeles County should be an acceptable option in all counties.

It is required to rebuild your fireplace/chimney from the shoulder up. You can reference the Information Bulletin on RECONSTRUCTION AND REPLACEMENT OF EARTHQUAKE DAMAGED MASONRY CHIMNEYS put forward by The City of Los Angeles Department of Building and Safety must be followed. If you are not in Los Angeles County you should consult with the local Authority Having Jurisdiction (AHJ) requirements for rebuilding a masonry chimney. The information bulletin put forward by Los Angeles County should be an acceptable option in all counties. In addition, all recommendations in the above fireplace should be completed prior to using the chimney.

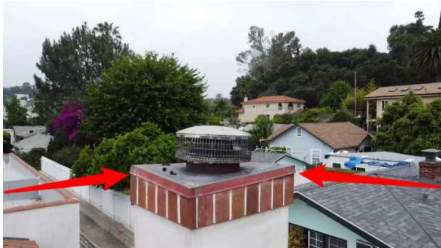
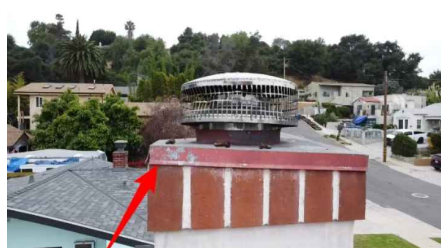
**16: Chase Cover: Potential Hazard
Flush Mounted Chase Cover**

The chase cover is located on top of the chase closet (chimney) and is designed to prevent water/moisture intrusion and critters from entering the chase closet. During our inspection we found your chase cover to be flush mounted causing it to be elevated on two sides. Chase covers require a gap between the chase cover and the chase closet to allow for proper ventilation and cooling of the chimney/flue system. In addition, the chase cover should have spacers raising the chase cover off the chase. It is recommended that you have a qualified professional replace the chase cover with a properly sized chase cover.

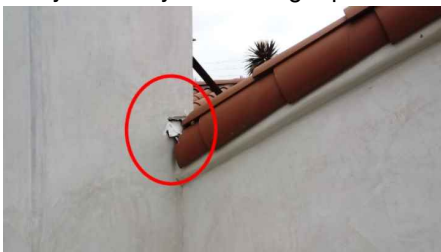
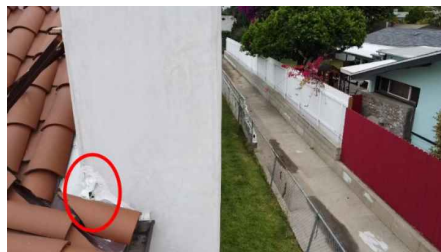
**17: Flashing: Potential Hazard
Replace Flashing**

In the course of our inspection, we discovered your flashing has been damaged, is rusting, and/or is not sealed to the chimney properly posing a water shedding hazard. The purpose of the flashing is to prevent rain and critters from entering the building structure. This is an area that commonly needs maintenance or repair to maintain its integrity. We recommend that you have your flashing replaced.
