Inspection Report

LOCATED AT:
1546 Hayworth Ave
Los Angeles, California 90035

INSPECTED ON:
Monday, November 20, 2023

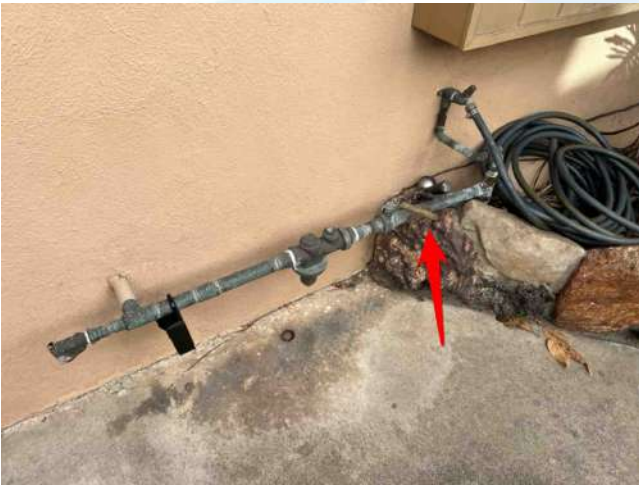
In the front of the building

Copper piping is viewed coming out of the ground by the building and as the main line runs underground from the street to the building, this appears to be the main water line. As the underground portion is not seen, no assumption is made as to its condition or material.

Serviceable.

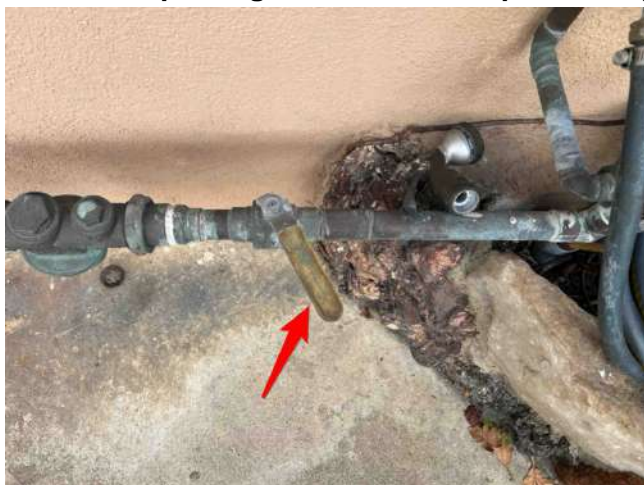
The main water line has been partially turned off, indicating that the pressure regulator is broken or turned up to high. It should be repaired / replaced and the water valve turned back fully on.

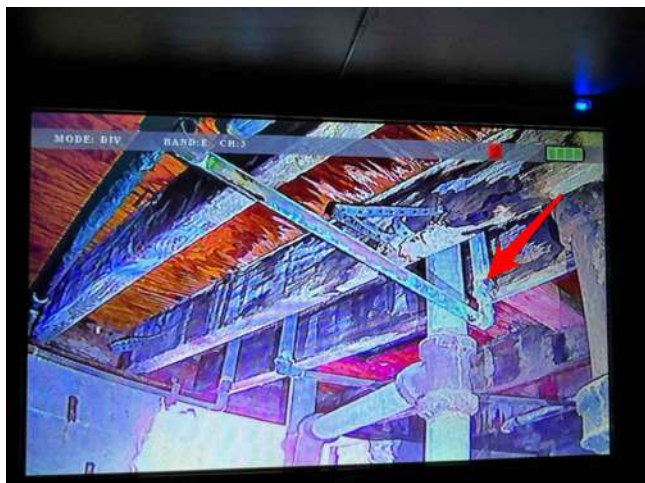
The water lines are a combination of copper and galvanized steel piping. The original galvanized steel piping that is left in the system for the risers and under sinks has rust and is showing deterioration. The remaining galvanized steel pipes will need to be replaced in the future as they continue to wear out.

There are copper to galvanized steel piping connections without the proper fittings that keep these dissimilar metals apart (dielectric or brass fittings). These metals react against each other without these fittings and the galvanized piping corrodes faster. Even proper fittings are just a temporary solution and will not correct or stop corrosion or handle the problems of pipes rusting out. The remaining galvanized pipes will need to be replaced in time.

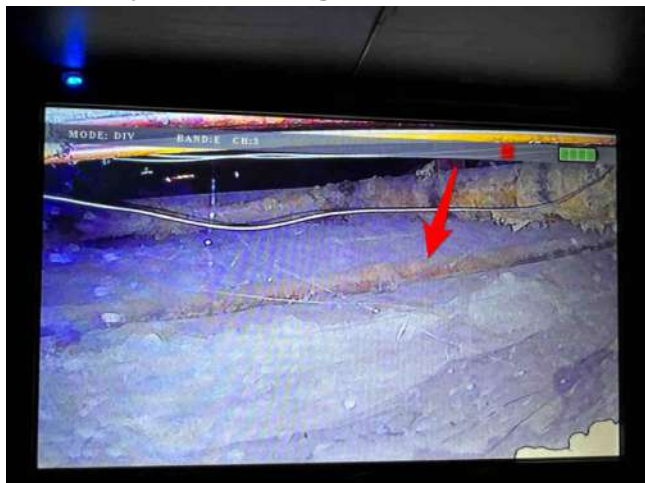
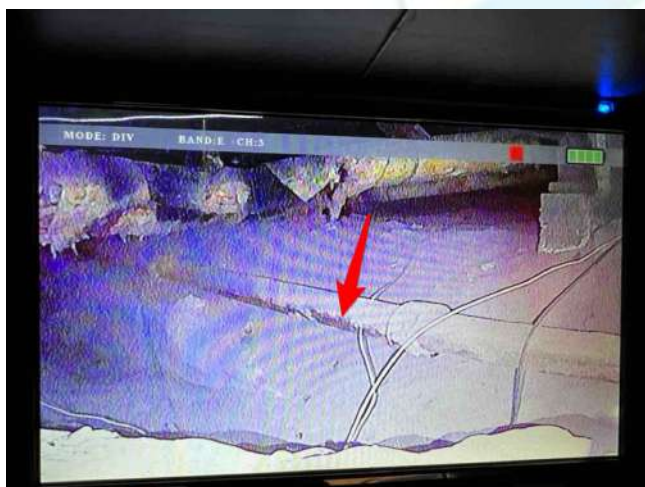
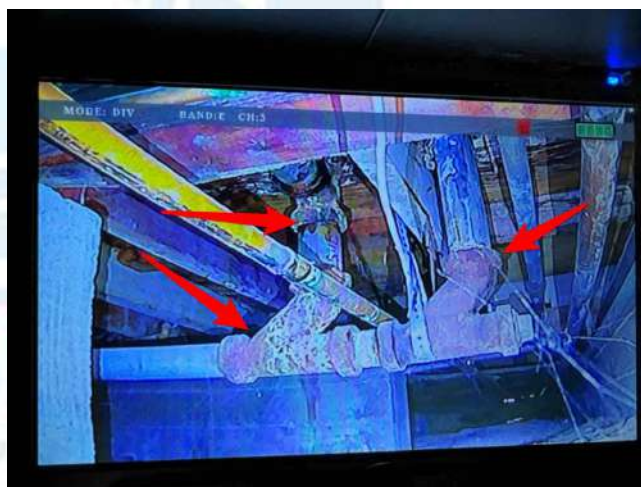
There are areas on the waste lines with rust blisters where the material is failing and may seep or leak at any time under the structure due to original cast iron in use that is at the end of its useful expected life span. These sections of pipe have failed and are ready for replacement at this time. The waste system should be fully evaluated by a plumbing specialist and repaired / replaced as needed.

Note: The water was not running while under the house, though it is noted that some apparent leaks may be occurring due to stains and water damage noted under the structure.

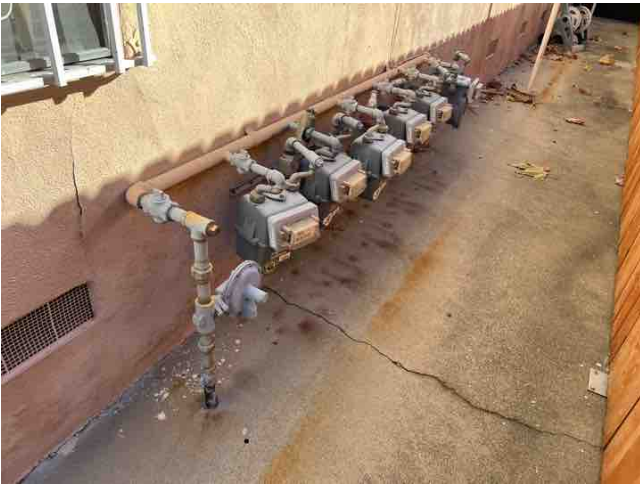
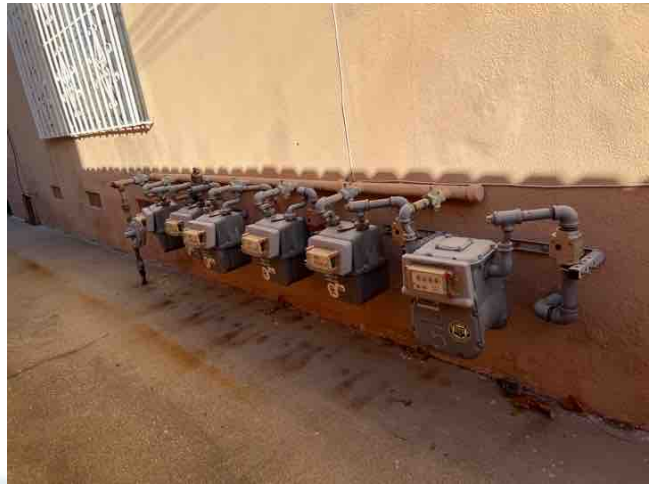
The 6 gas meters are located on the right side of the building

Needs Attention: The unit 4 gas was shut off at the meter and locked by the gas company. The gas systems in this unit were not tested such as the heater and gas stove / oven.

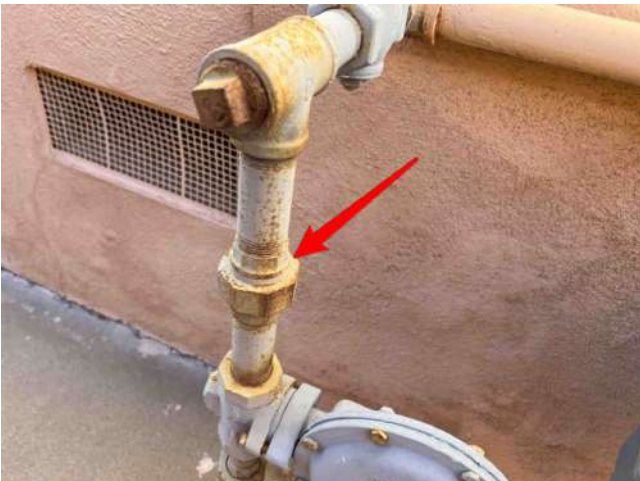
There are areas of rust on the gas piping on the property, these were seen at the meters .

It is advised to have the gas provider inspect the gas system to determine its condition and check all the gas appliances and fixtures. This is usually a free service.

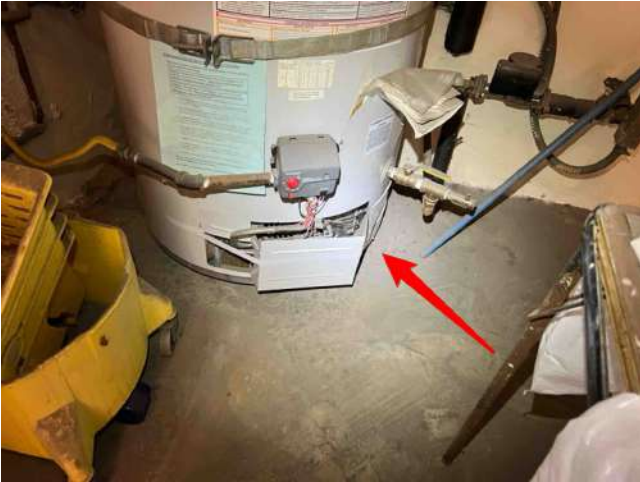
There is no drain pan below the water heater and this is advised in case the water heater leaks so that the water can be carried away from the living space.

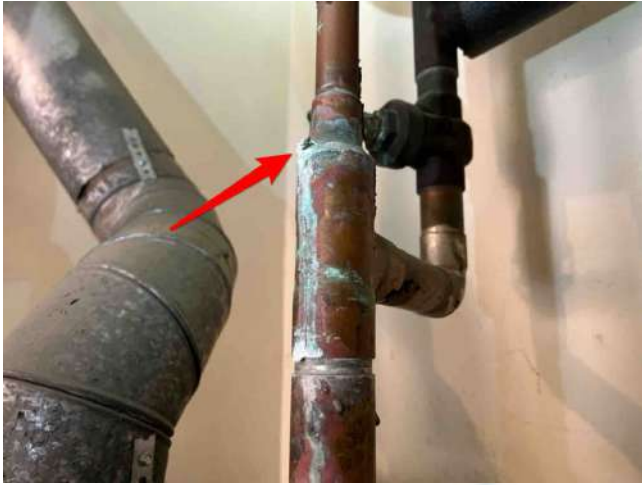
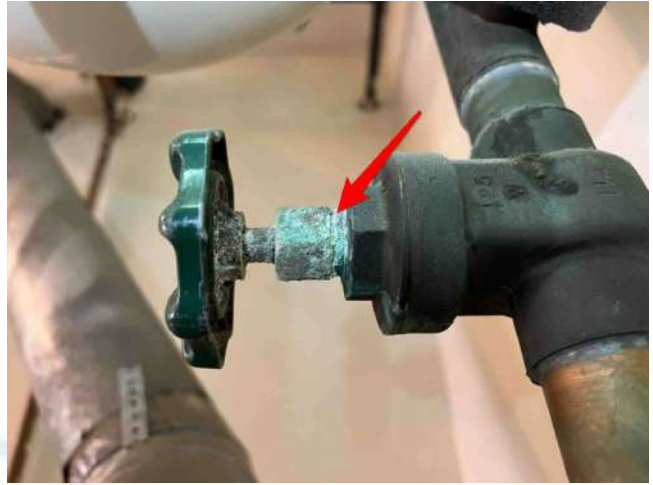
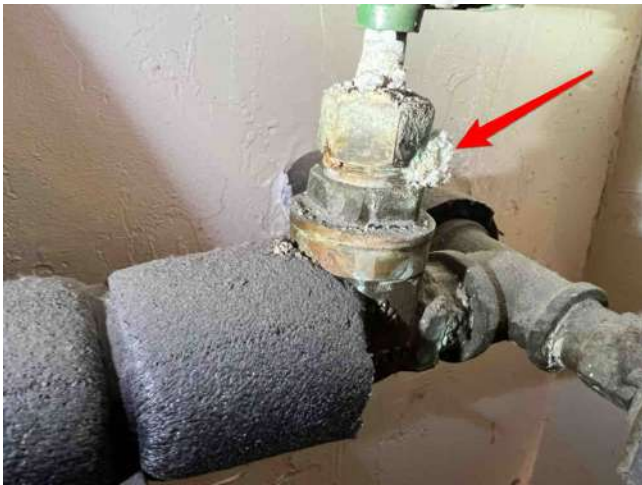
Needs Attention: Areas of corrosion to some plumbing connections and older valves should be repaired and older valves replaced with modern ball valves.

The water heater is old and nearing the end of its expected life span.

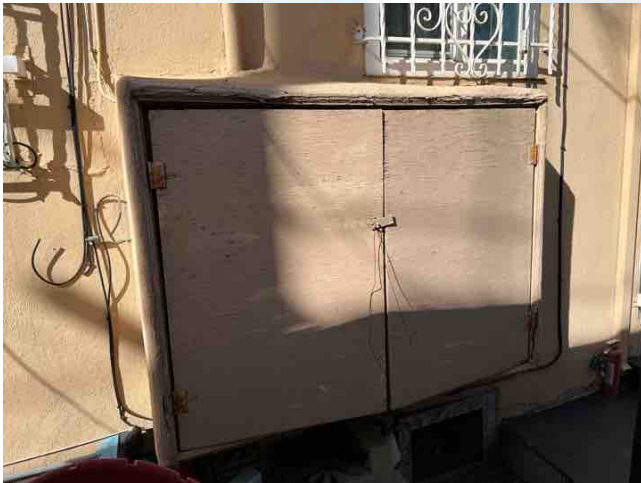
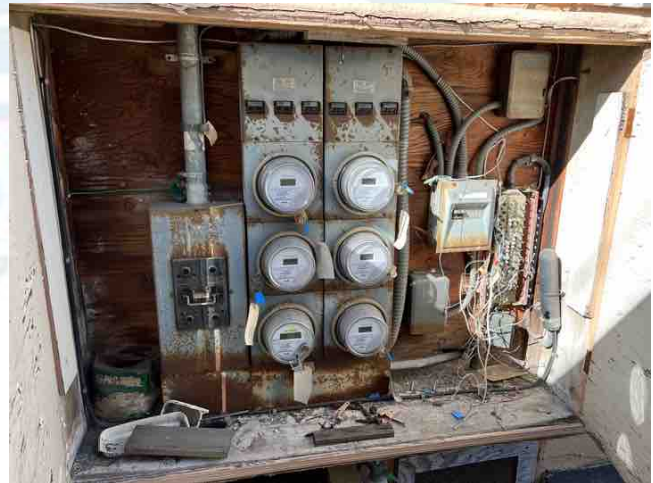
The main panel is located at the rear exterior in a cabinet. 6 meters and main breakers. 1 for each unit and 1 for the "house" common areas.

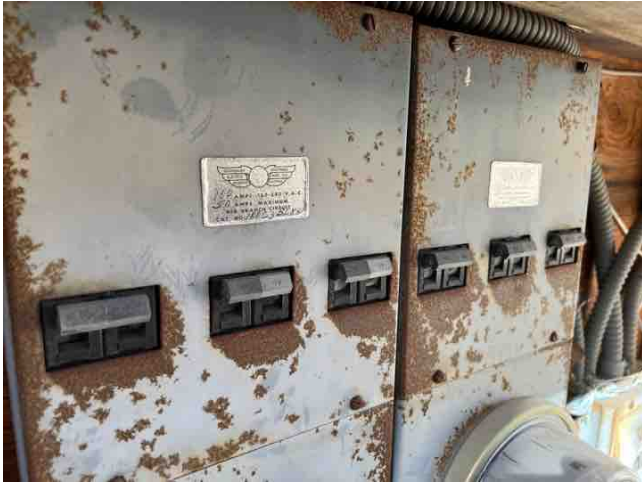
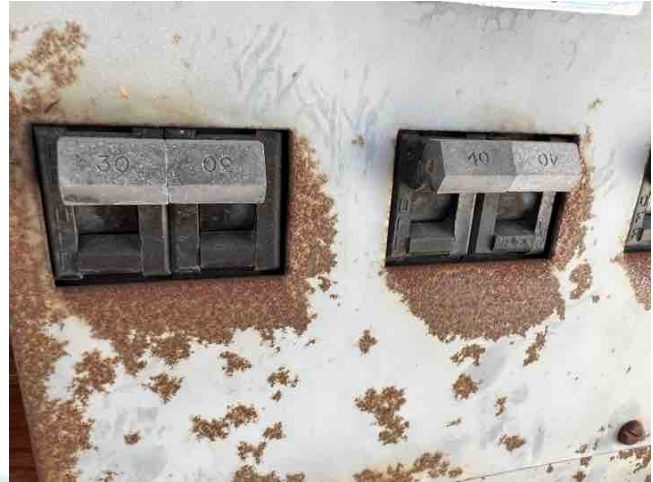
Service Amperage - 40 Amps for each unit and 30 Amps for the common areas.

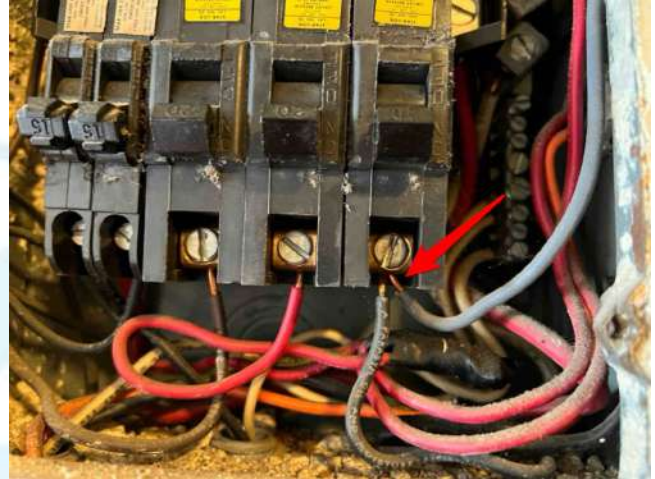
At unit 5, There is more than one wire connected to a single circuit breaker, where only one wire should be connected to each breaker. This can sometimes cause overloading of the wires or breakers. It also can cause the wires to have improper contact with the breaker and arc between the wire and the breaker.

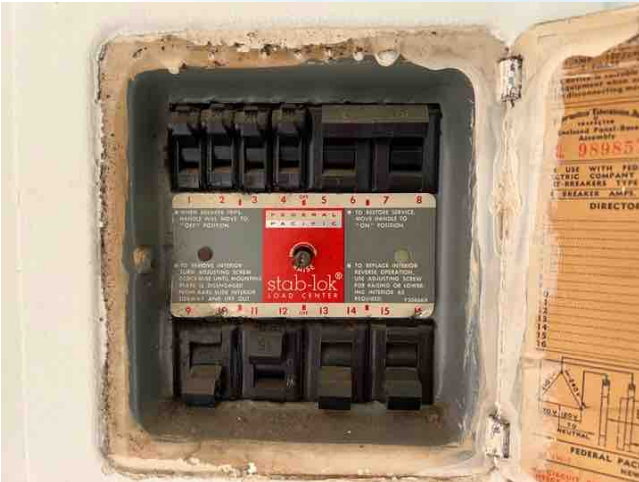
This panel and circuit breaker system is an old "Stab-Lok" or "FPE" (Federal Pacific Electric) system. It is past the end of its expected life span. As with all older systems it will be more prone to failure due to its age and design. Some of these older systems have a reputation for unreliability, failing to trip, jamming, or overheating. Electricians may recommend the panel be replaced for safety.

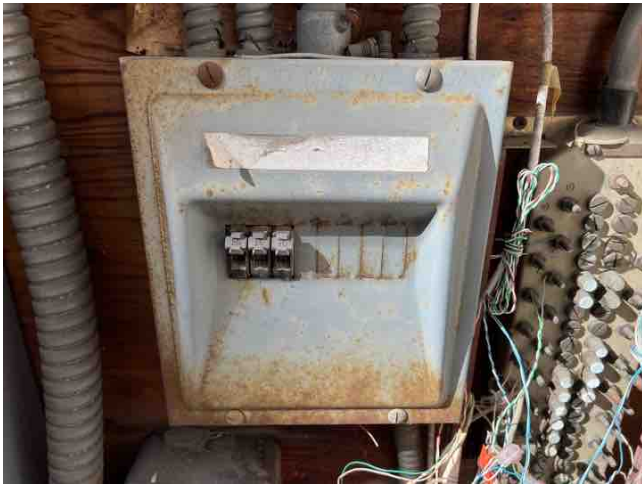
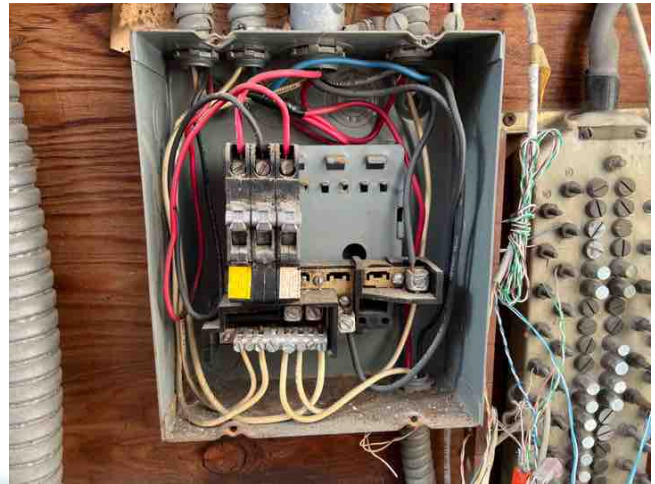
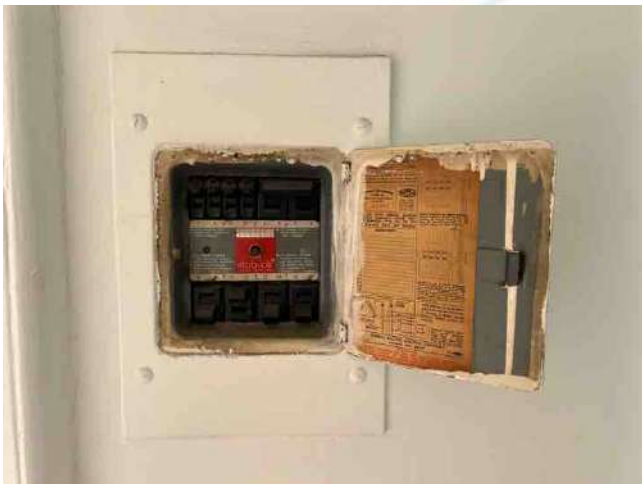
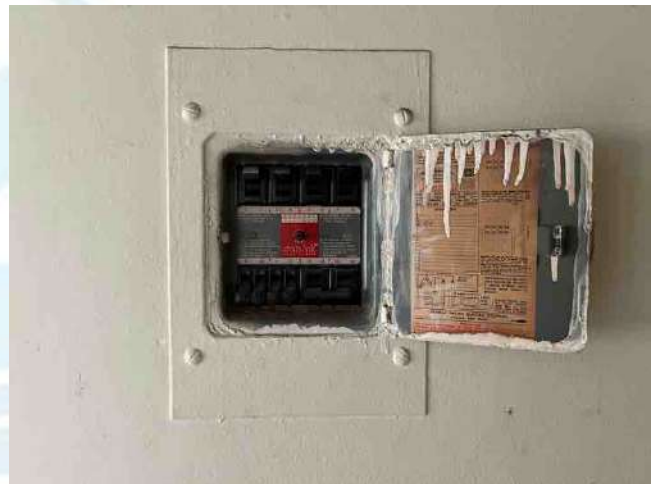
The circuit breakers in the panel(s) do not have a complete directory so it is not known what each breaker controls (or protects) in the building.

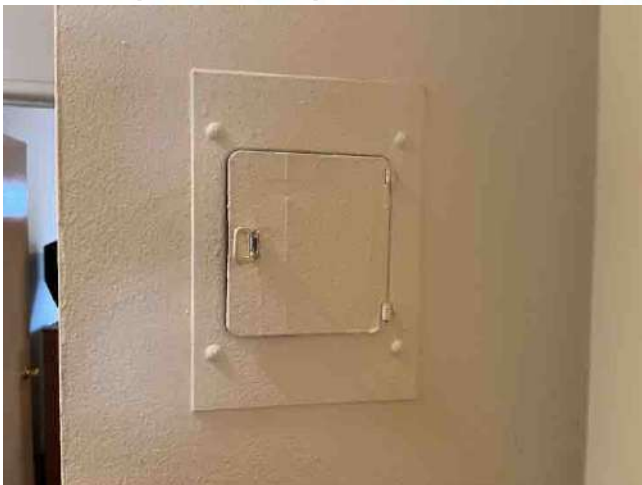
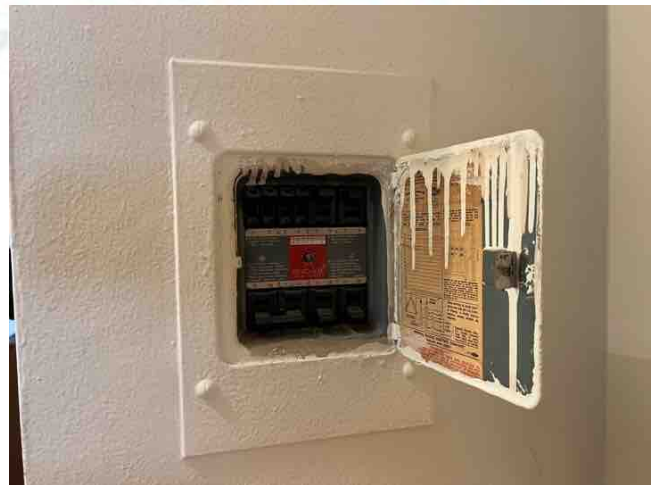
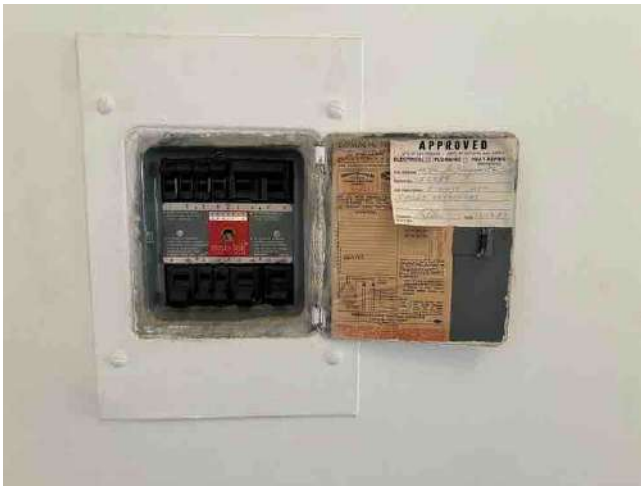
Units 1-4 panels were painted onto the walls and the covers were not removed.

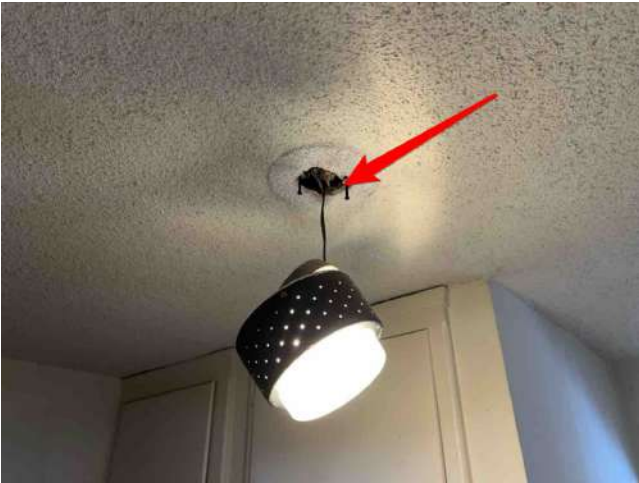
Not Acceptable: There is a fixture that is hanging down from the ceiling with exposed wires such as in the unit 5 hall.

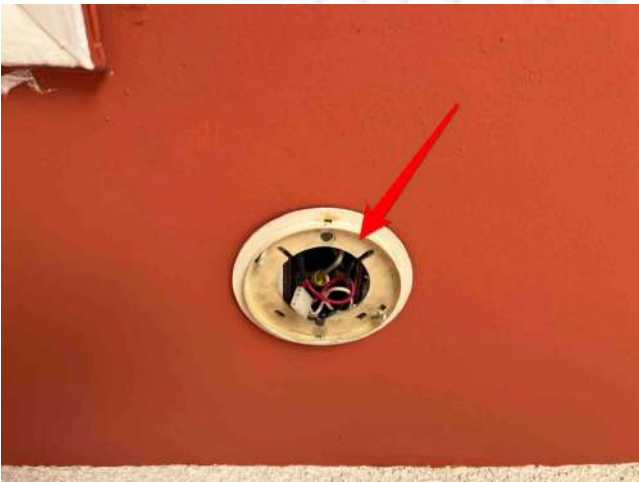
There are missing smoke detectors in areas such as in unit 2 bedrooms and throughout unit 3.

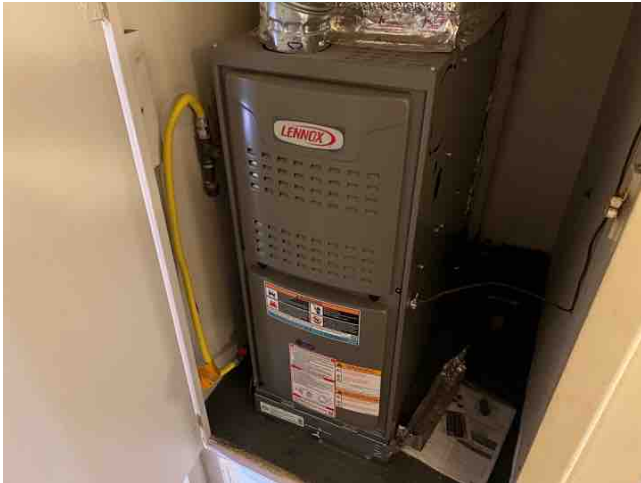
Serviceable for unit 1. Upgraded central HVAC system.

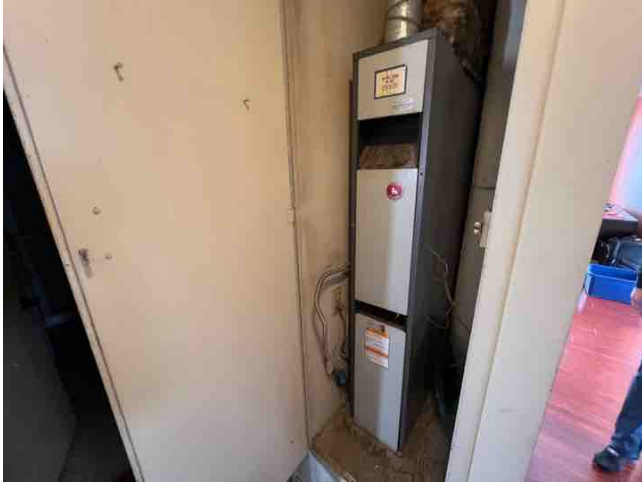
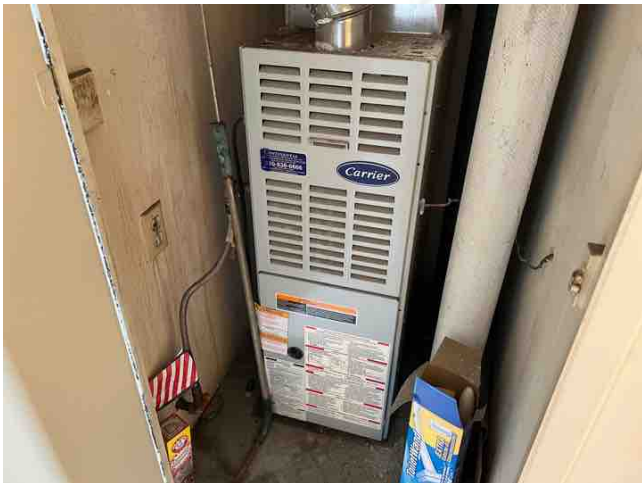
Not Acceptable: inoperative systems found for unit 2, 3, 4 and 5.

These systems are old, past their expected 15-20 year life, are of working, are off or blocked and will need to be repaired / replaced. Three appear original and one is from 2001.

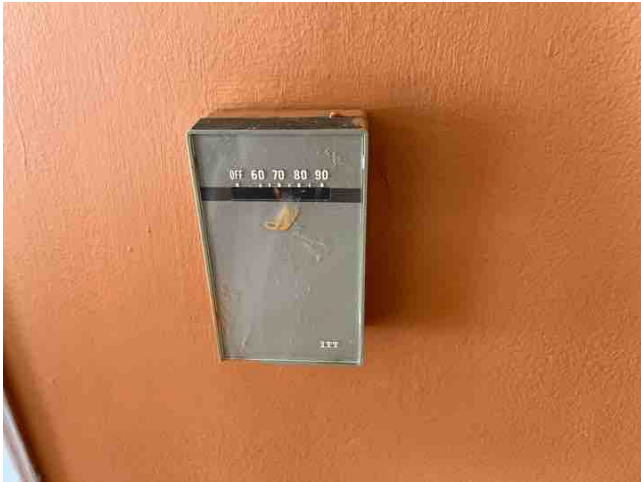
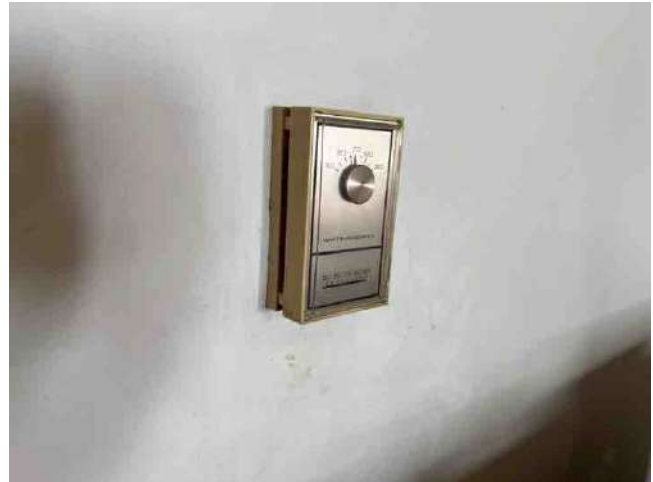
The thermostat is old and nearing the end of its life for units 2, 3, 4 and 5.

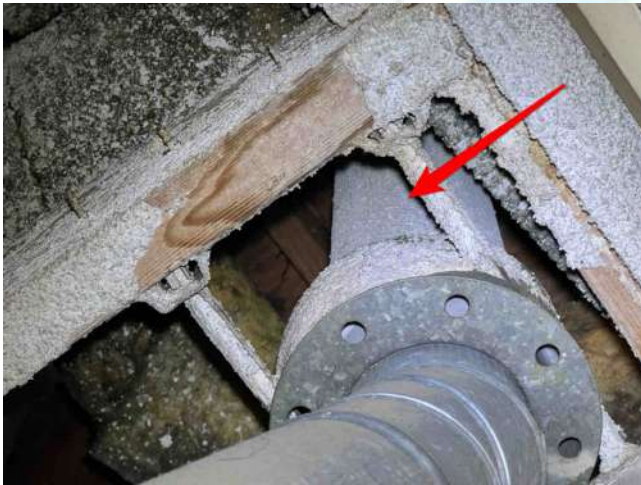
The furnace vent line goes into piping made of older materials. Many manufacturers specify that a new metal vent pipe be installed when the new furnace is installed. This older piping can allow condensation to run back into the furnace causing it to rust prematurely or not vent properly. Some of these older vents have been known to contain asbestos.

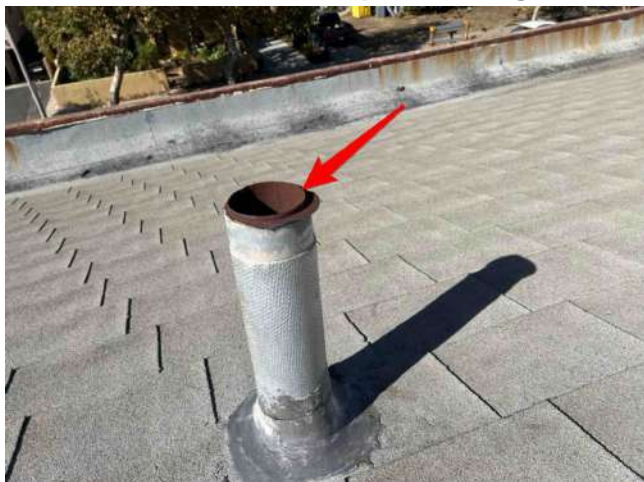
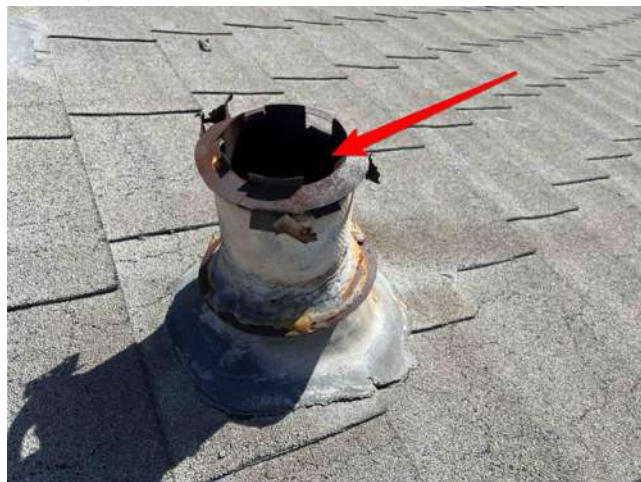
The roof weather / rain cap is missing and the vent / caps are rusted in areas.

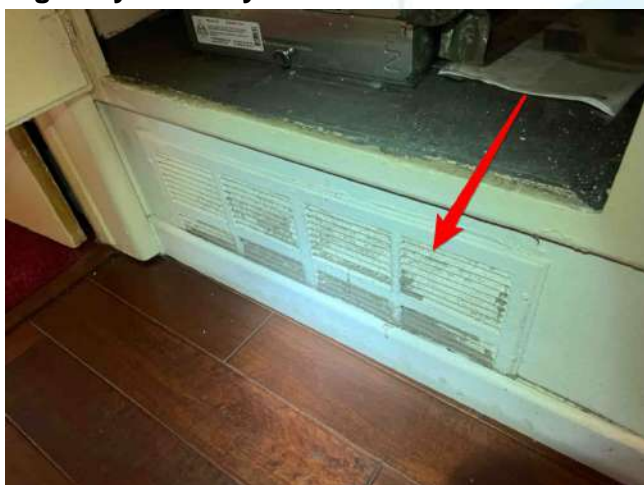
The air filter is dirty and needs to be replaced (or if reusable, cleaned). It should be changed regularly for all systems.

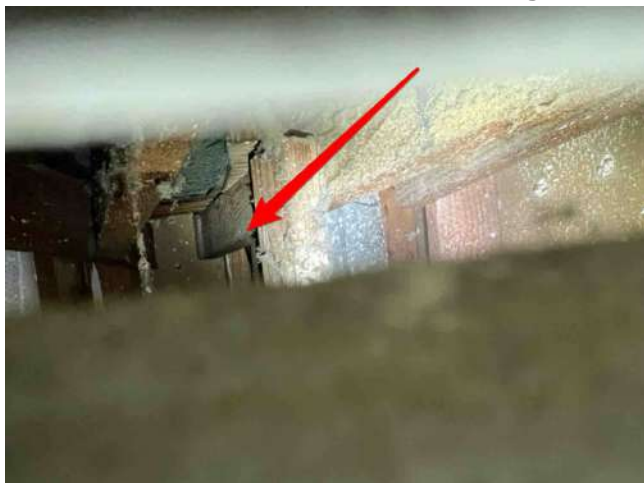
This air return is drawing it's "supply air" from the walls / ceilings in an unsealed return. This is no longer recommended as this can draw in odors, dust, etc from inside the walls / ceilings, and is less efficient as this air requires more heating / cooling, and causes the conditioned house air to be expelled through house cracks and gaps to make room for this new air to enter. It is recommended that a return duct and grill be fully sealed.

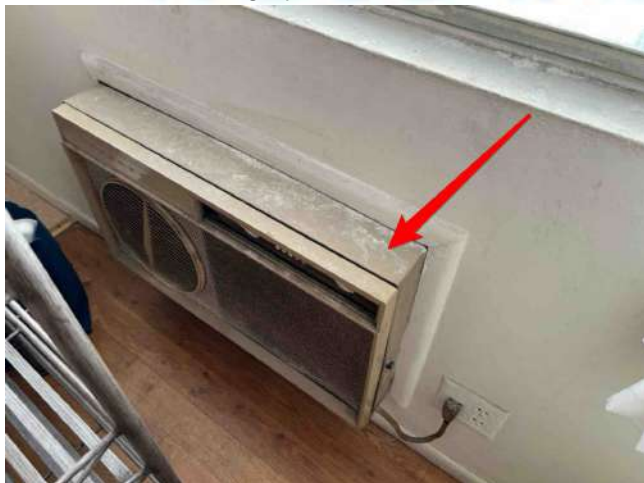
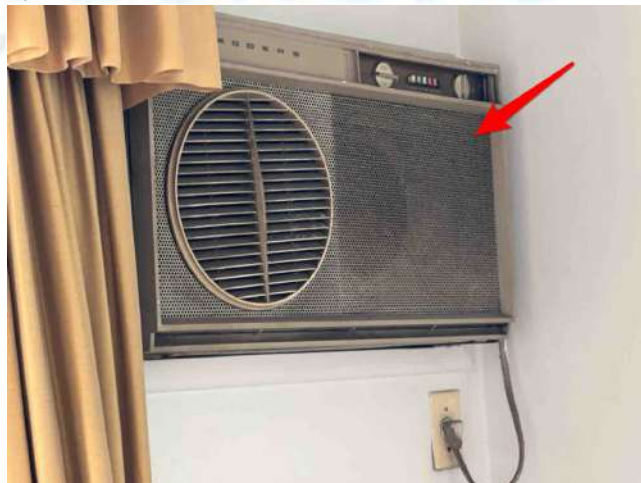
The air conditioning systems are the window or wall style units

Not Acceptable: the systems are older and inoperative or blocked. They should be repaired / replaced as they are well past their expected life span.

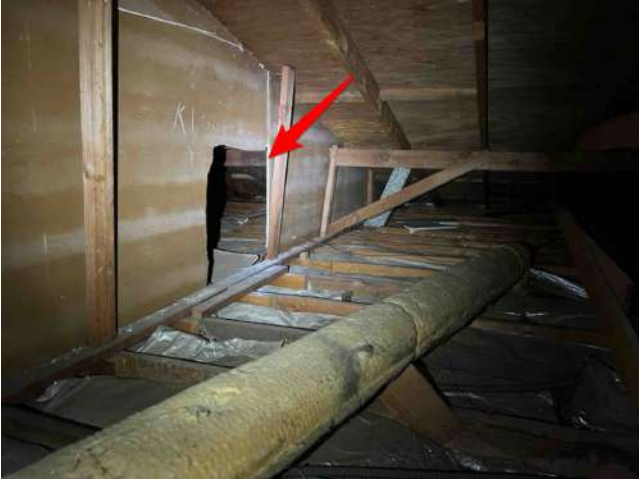
ACCESS CONDITION

There is not a complete firewall separating each unit's attic space as is recommended to reduce any risk of fire and one of the firewalls is damaged / has a hole.

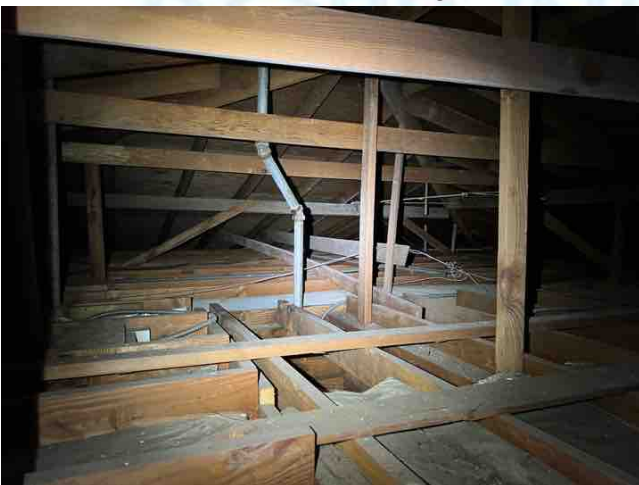
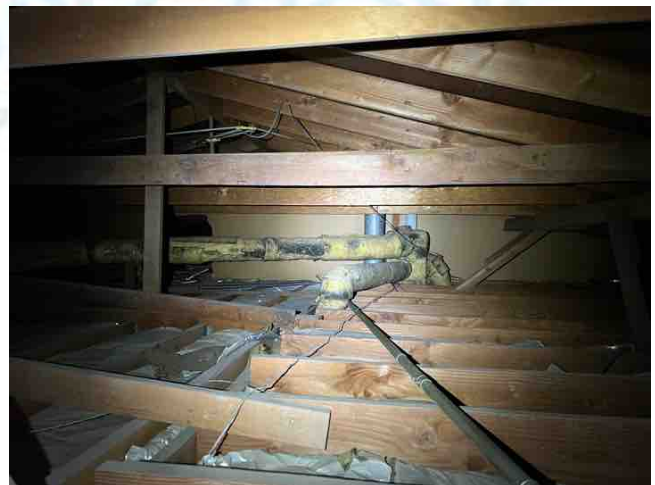
TYPE OF ATTIC FRAMING

The attic has conventional framing in it

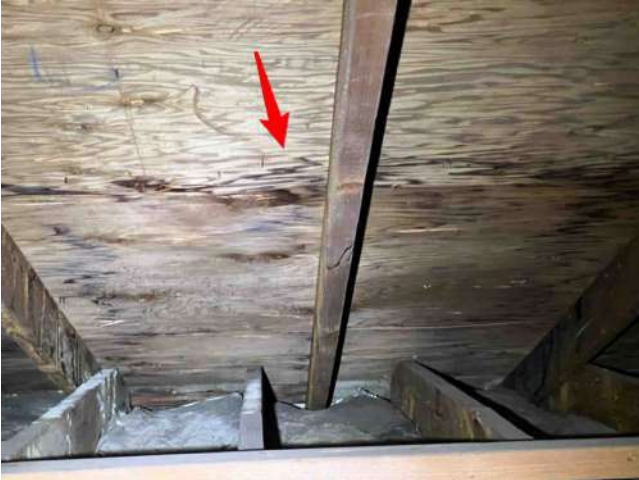
ATTIC FRAMING CONDITION

There are areas of stains on the framing lumber. See roof notes for details on any needed repairs.

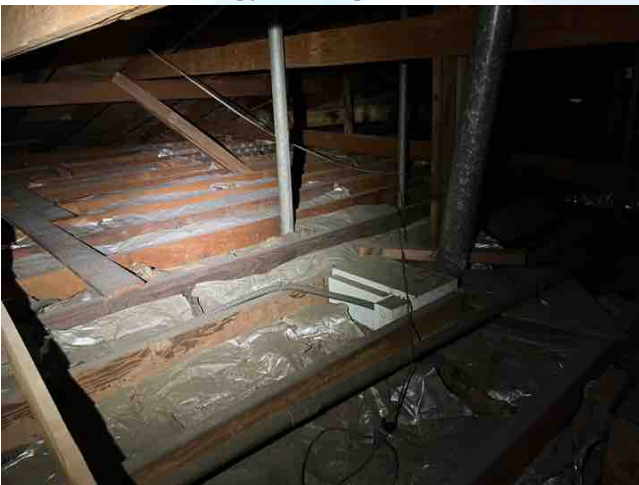
INSULATION CONDITION

There is little insulation provided in the attic. When this building was built it was not common to install the amount that is required today. 8 - 12 inches of insulation is standardly recommended in the attic for energy savings.

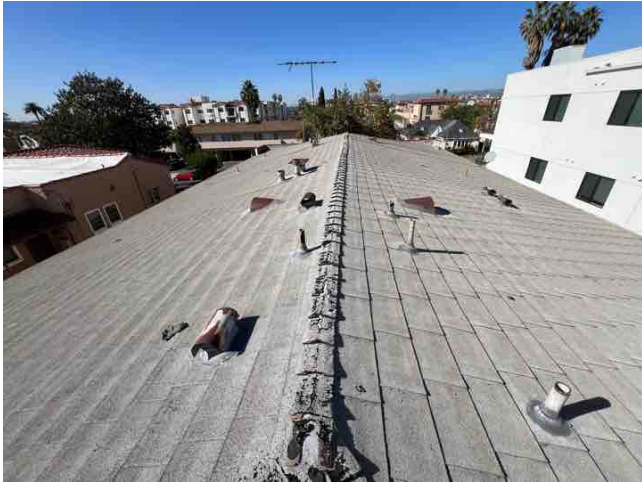
SLOPED ROOFING MATERIAL

The roofing material on the sloped roof is made of composition shingles.

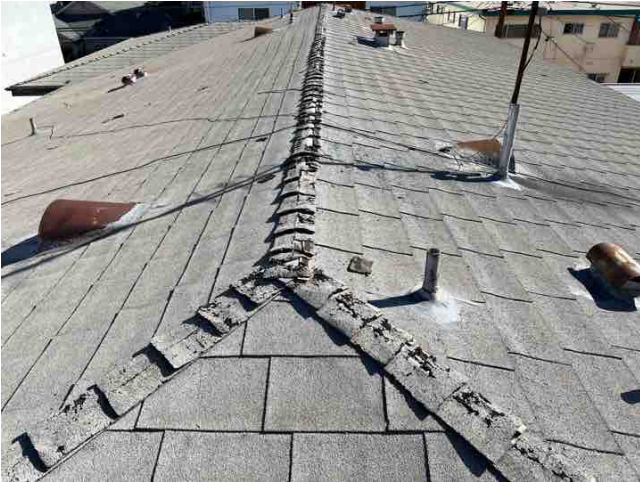
SHINGLE ROOF COVERING STATUS

Not Acceptable: all the ridge caps need to be replaced on the roof as they are missing / damaged.

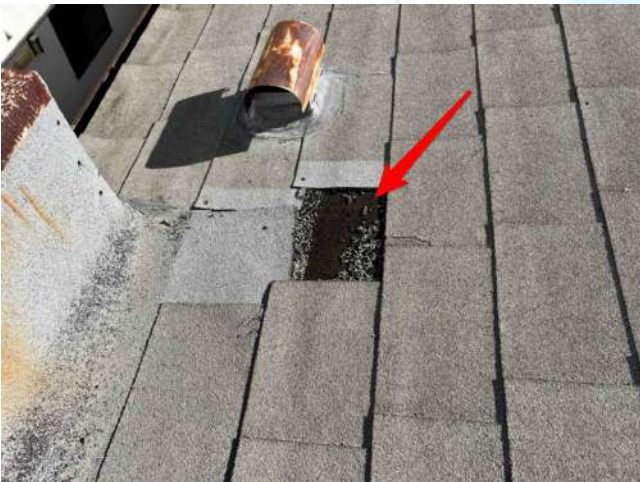
There are areas of damaged and deteriorated shingles.

Note: the shingle roof has cracking and wear due to age, it is near or at the end of its expected life span.

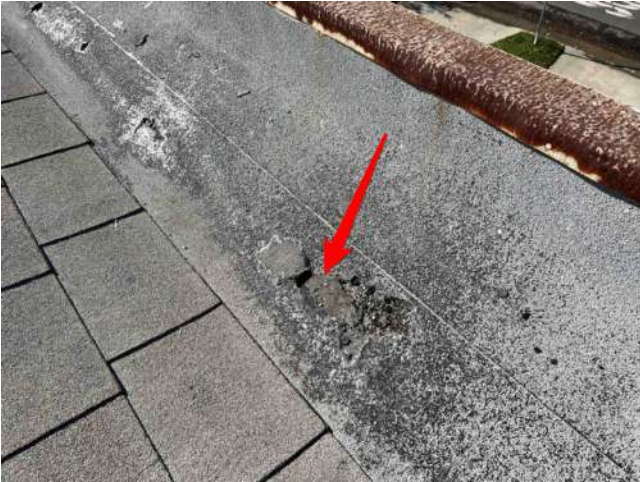
FLAT ROOF COVERING STATUS

Not Acceptable: the front section of rolled roofing has holes, damage and will need to be replaced.

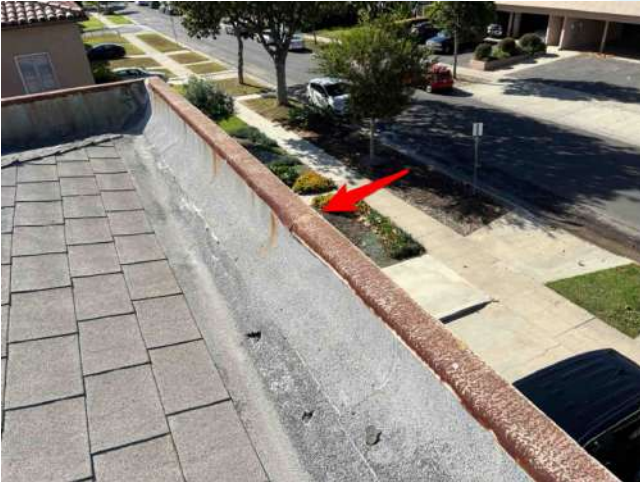
Needs Attention: the front parapet cap is rusted and should be replaced.

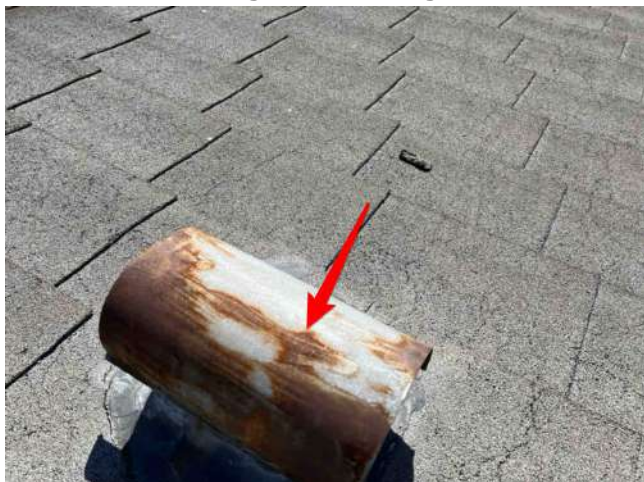
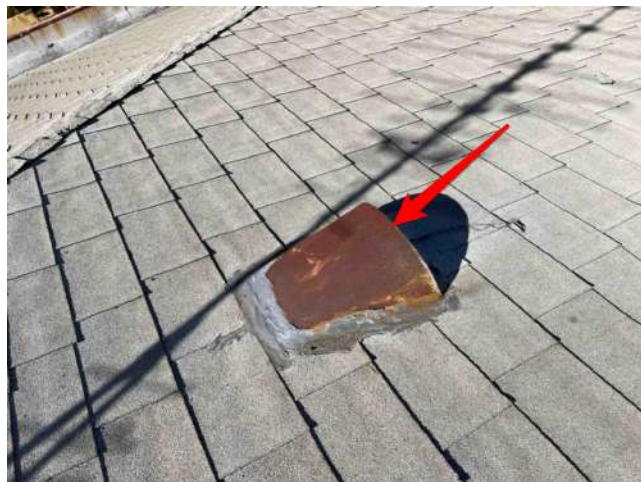
The metal flashings are rusting and corroded in areas.

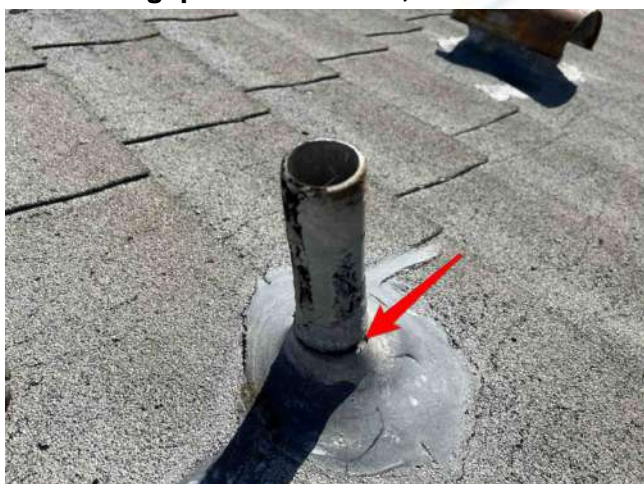
There are gaps in the mastic, where the mastic is cracked and in need of repairs.

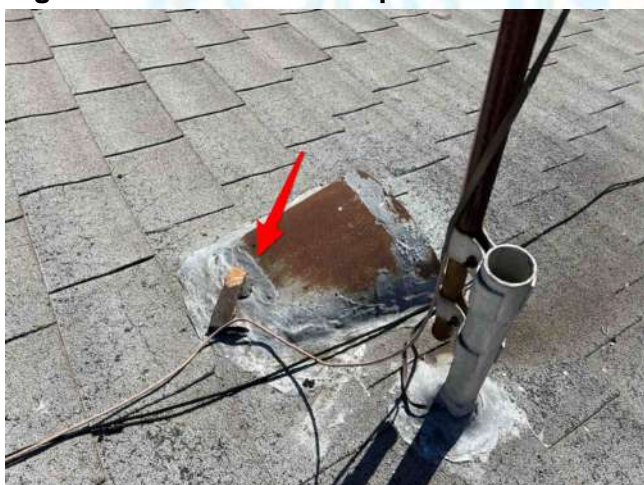
The flashings have been covered over with mastic which is a temporary solution and will require regular maintenance to help ensure a leak free condition.

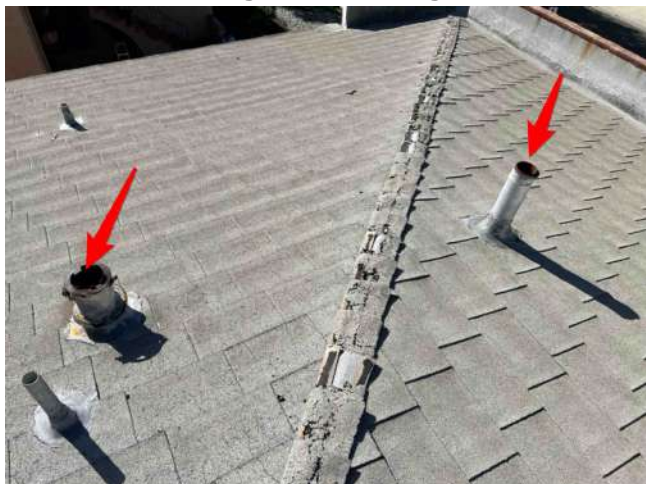
There are flashings with missing rain / weather caps.

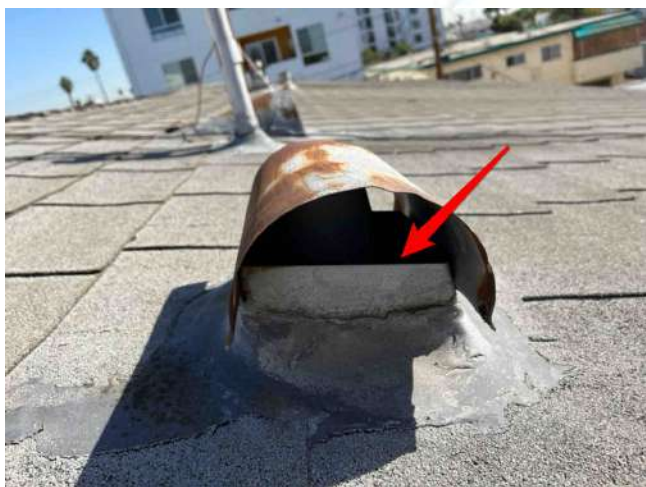
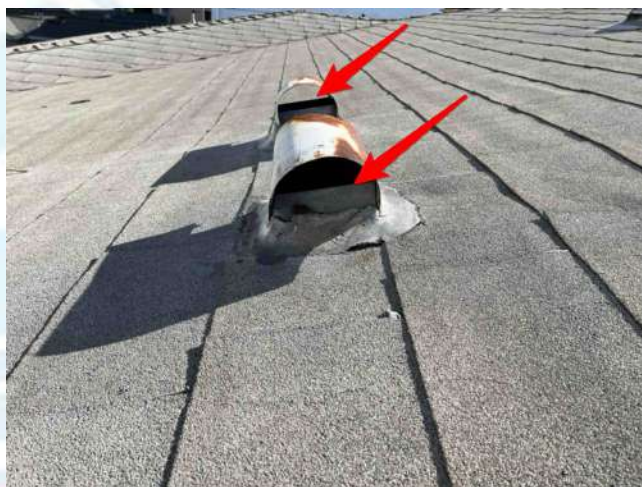
Some of the flashings are missing screens to prevent animals from entering into the area below them.

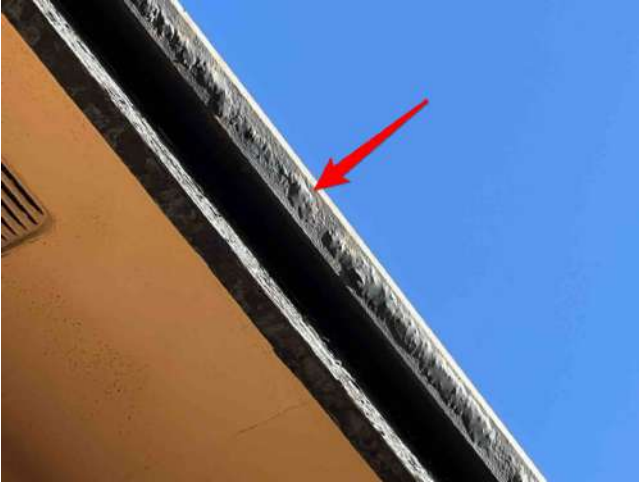
GUTTER CONDITION

There are rusty areas in the gutter system.

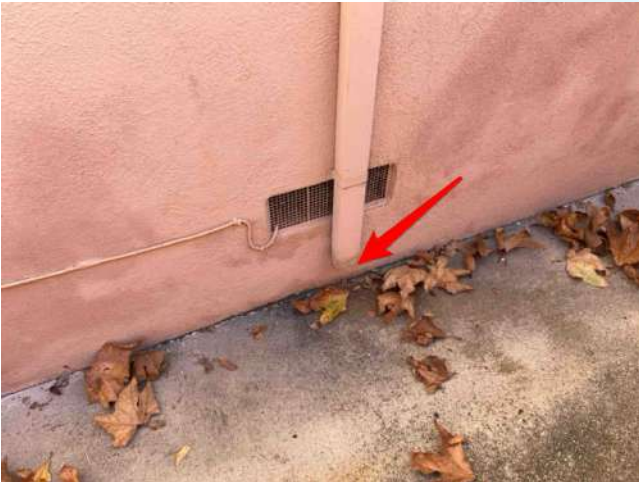
DOWNSPOUT CONDITION

The downspouts do not all route the water away from the building but instead deposit it next to the structure which commonly causes problems to the foundation over time. Ideally these would extend 4-6 feet away from the foundation.

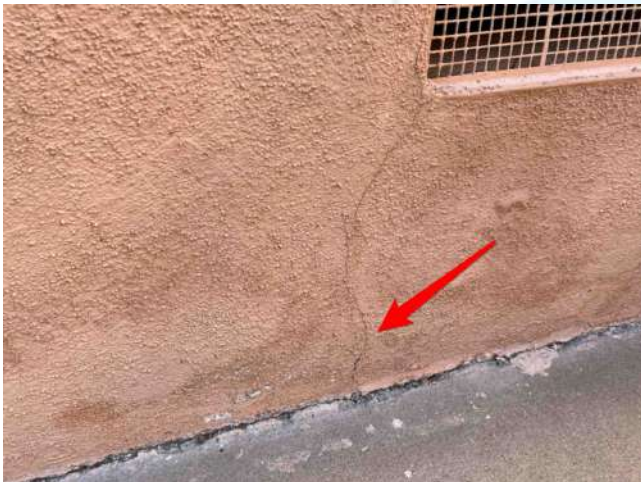
There is typical cracking in the exterior stucco.

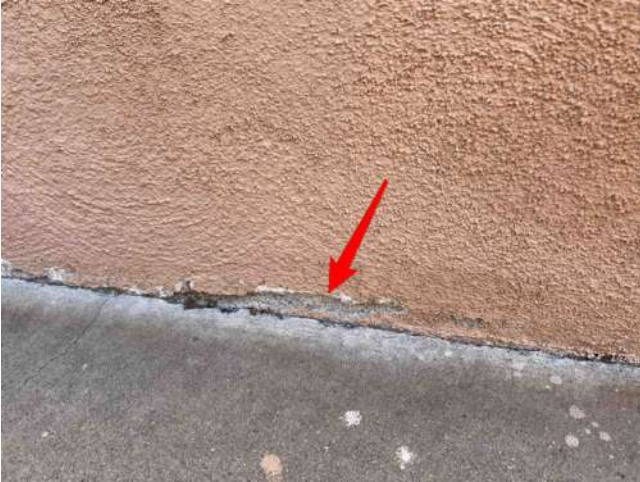
The stucco has minor peeling and some deteriorated in areas near the level of the soil.

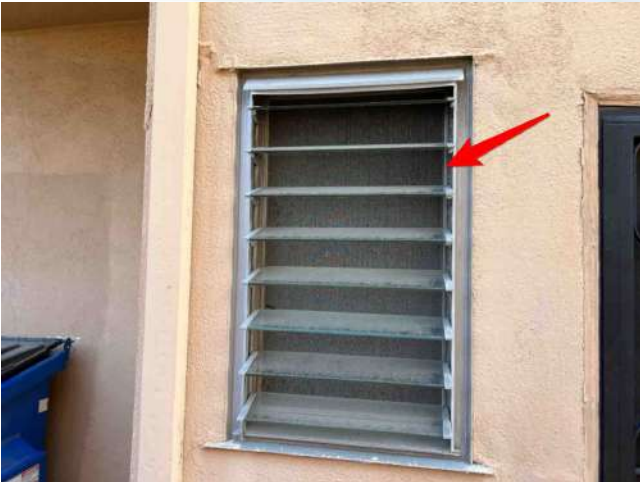
Needs Attention: the older jalousie type (glass slats) window at the laundry should be replaced for security.

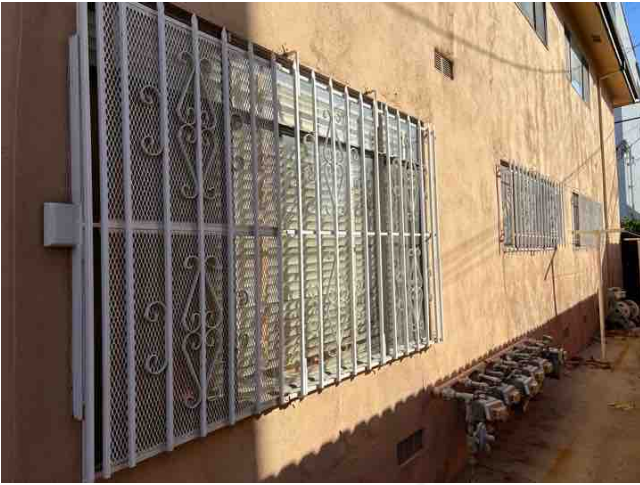
Needs attention: some rust and wear noted on exterior bar surfaces.

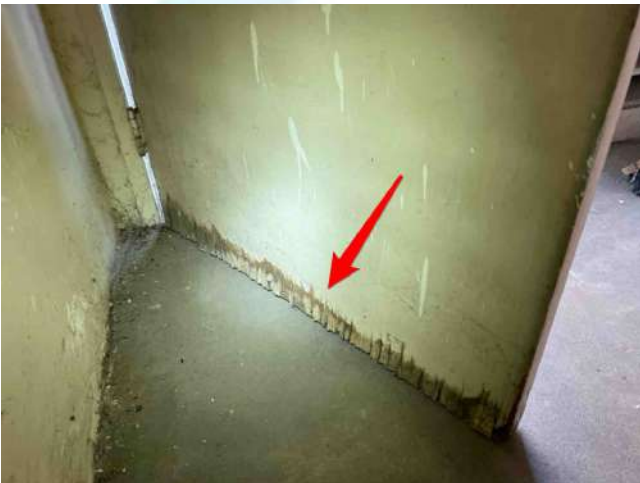
Needs Attention: the laundry exterior door is damaged it should be replaced or repaired with an exterior weather rated door.

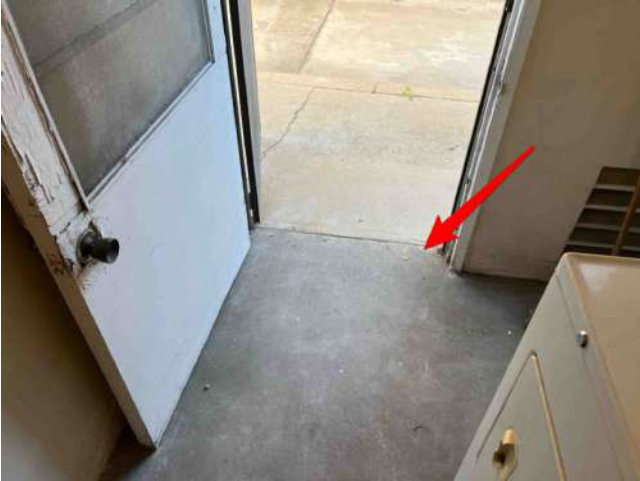
There are areas missing thresholds to prevent water intrusion such as at the laundry.

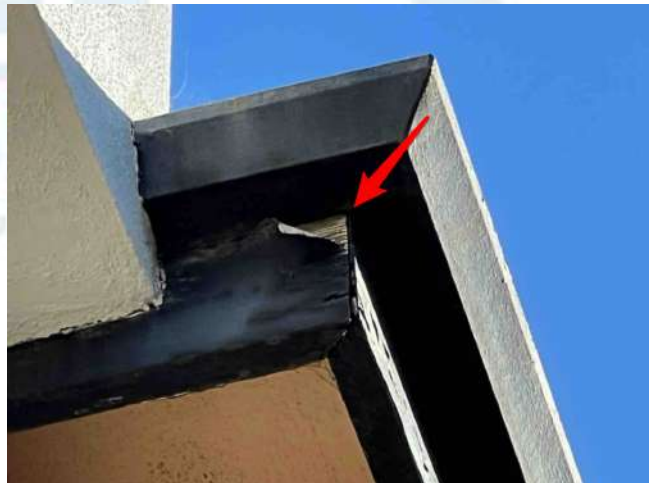
The trim is deteriorated in areas.
