Inspection Report

LOCATED AT:
1546 Hayworth Ave
Los Angeles, California 90035

INSPECTED ON:
Monday, November 20, 2023

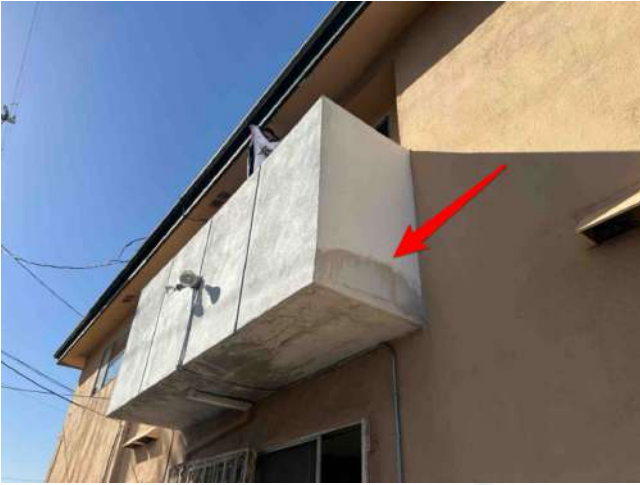
BALCONY CONDITION

Not Acceptable: the rear exterior unit 5 balcony is heavily damaged and appears to be leaking. It will need repairs / replacements.

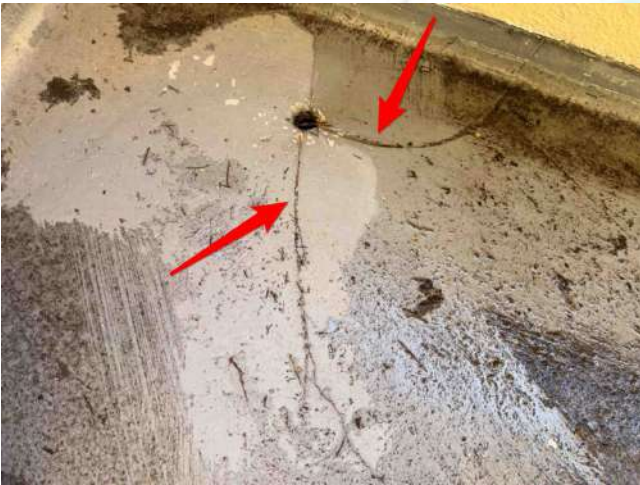
There are cracks in the surface of the balconies for units 3, 4 and 5, these should be repaired to prevent moisture intrusion into the structures.

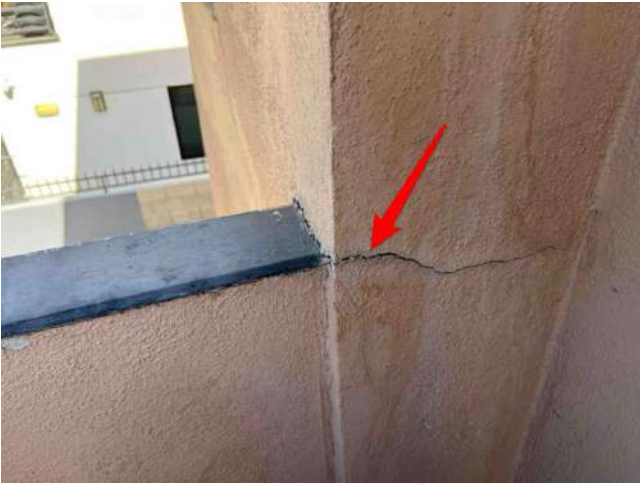
Needs Attention: there is cracking in the stucco railings and wall connections as from settlement which may be due to moisture getting into the balcony / deck due to surface cracks.

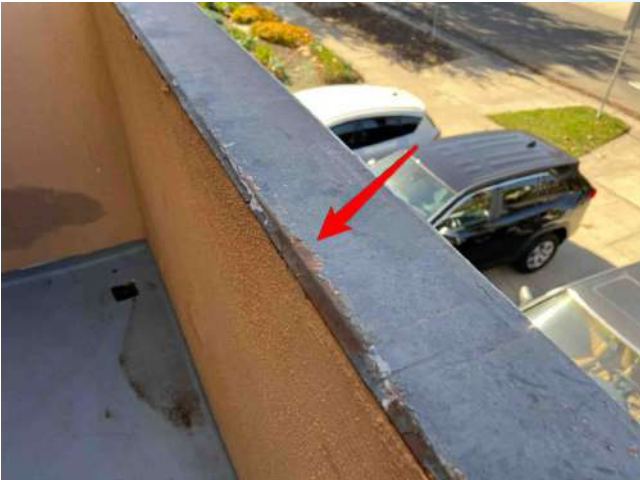
The railings are worn and the paint is peeling.

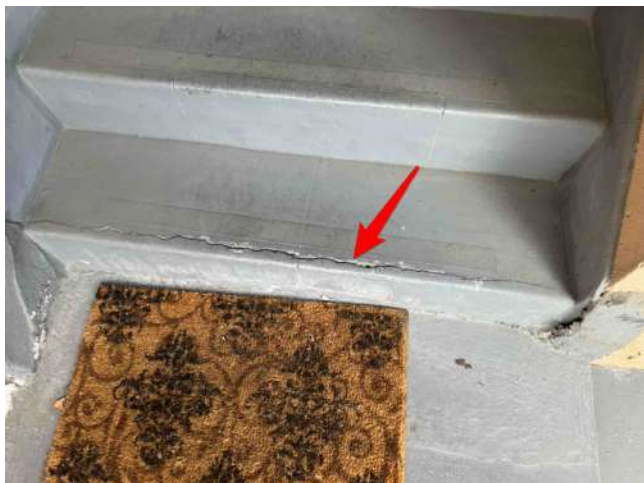
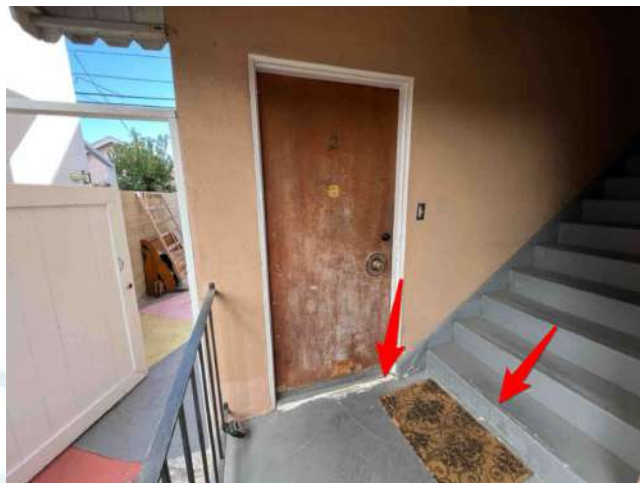
EXTERIOR STAIRS

Needs Attention: the stairs are cracked / damaged at the front and rear steps at the bottom of the stairs.

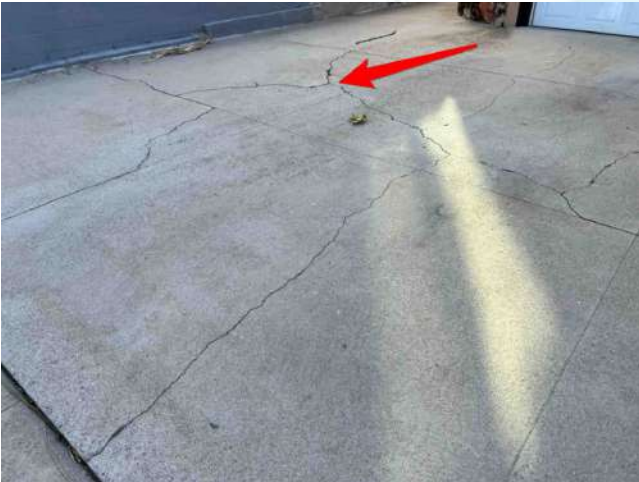
There are cracked areas in the driveway that are typical for the age and style of construction.

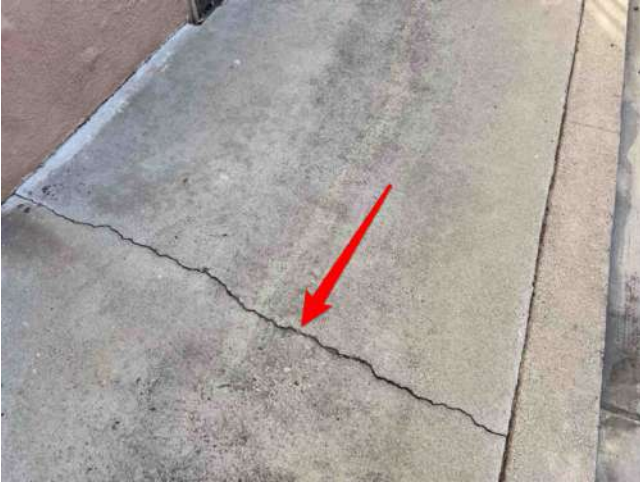
WALKWAYS

There are cracked areas of the walkways that are typical for the age and style of construction.

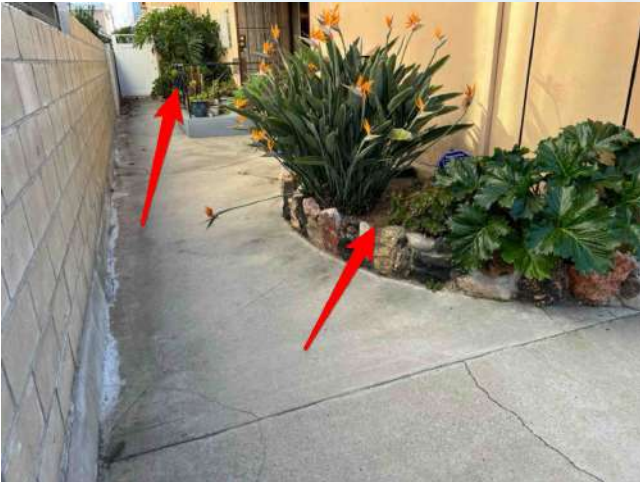
DRAINAGE CONDITION

There are planters that may not be properly drained and may not have proper moisture barriers to prevent seepage into the structure

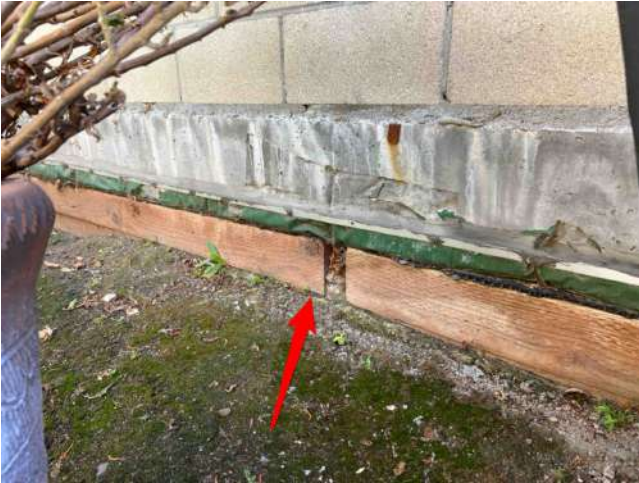
Needs Attention: the left over wood forms under the rear block wall should be removed and concrete added to support the areas.

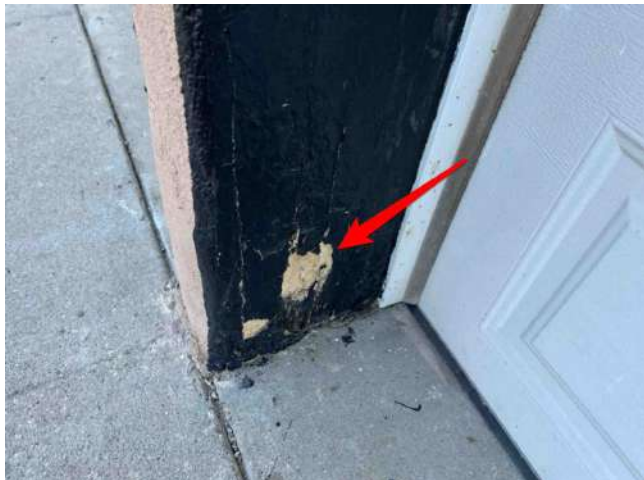
There are weather beaten areas of the garage jambs

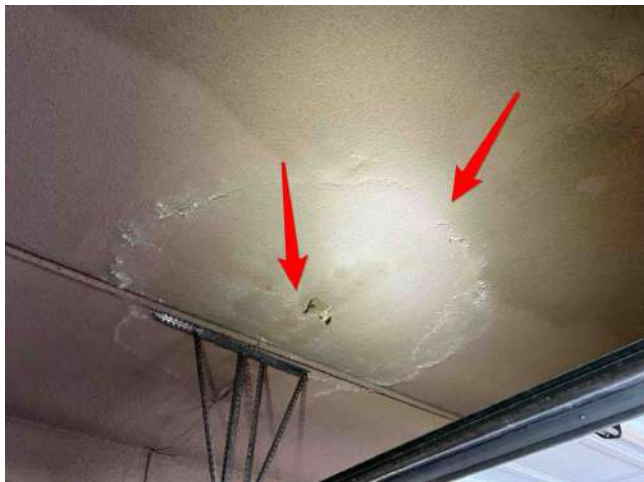
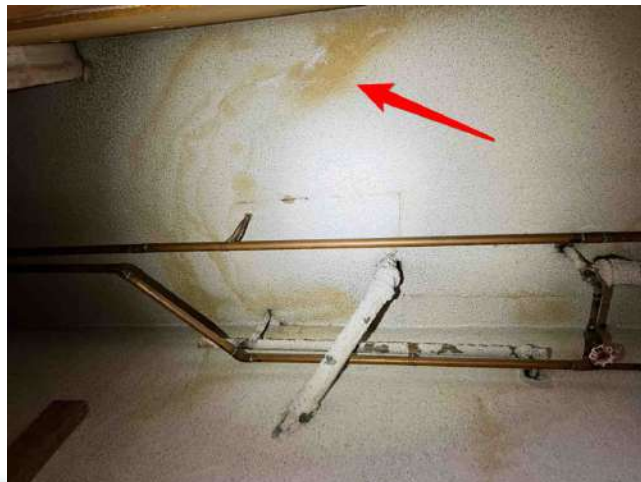
The garage interior has areas of moisture stains and damage on the ceiling between the left two doors and in the cabinets.

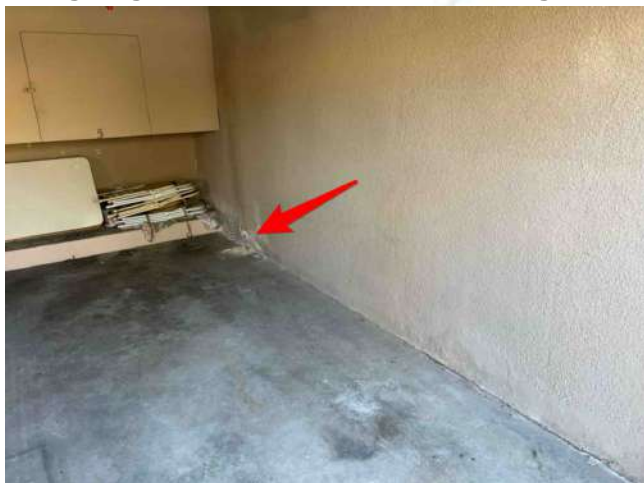
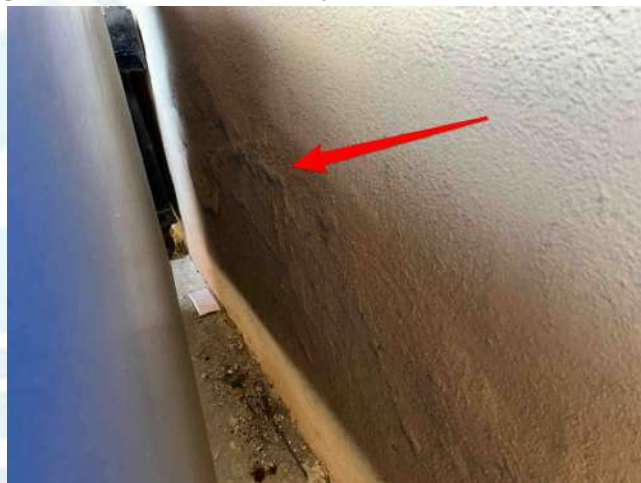
The garage interior has areas of damage at the right lower wall. This may be moisture related.

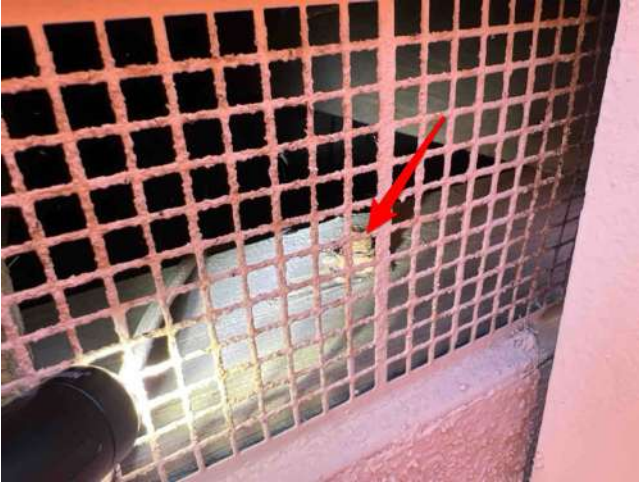
The structure has some original anchor bolts. There are not many of these bolts and it does not meet today's standards that have been established for bolting. This would be evaluated by a foundation expert if additional work was to be undertaken to bring it up to these standards.

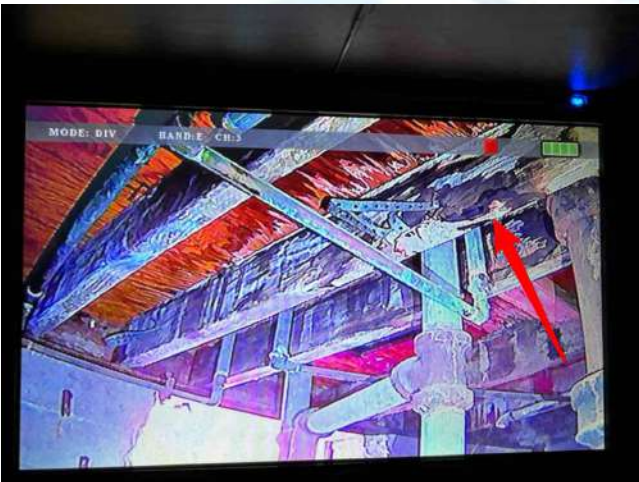
There are stained and deteriorated areas of floor framing - it is advisable to consult the structural pest control operator report for more information on this situation.

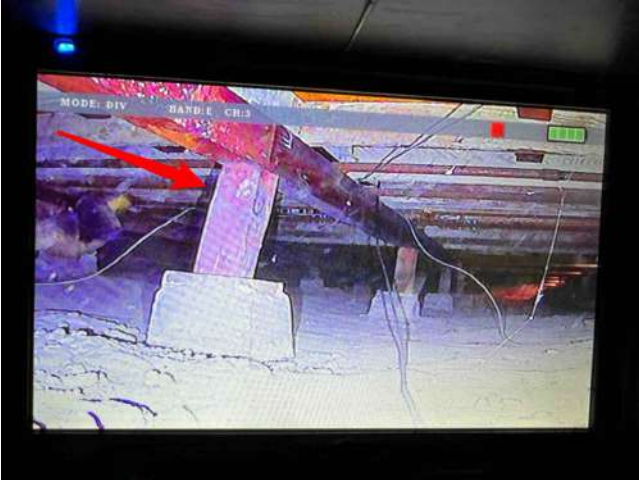
Some posts have shifted and are out of plumb.

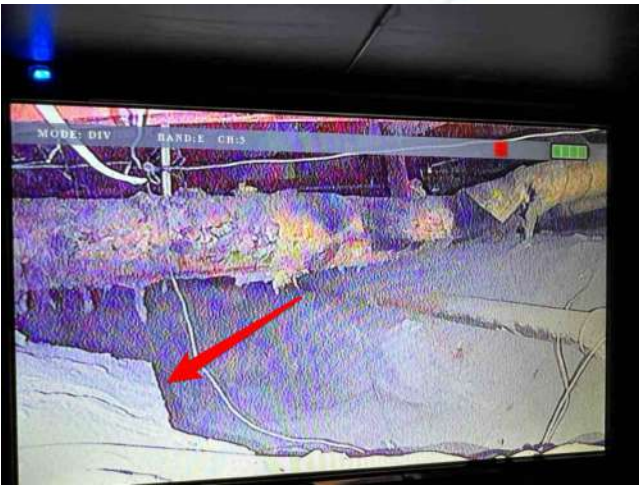
The piers and posts that hold up the structure are undermined in areas where the earth under them has been removed. They do not have full bearing on the soil and cannot give full support.

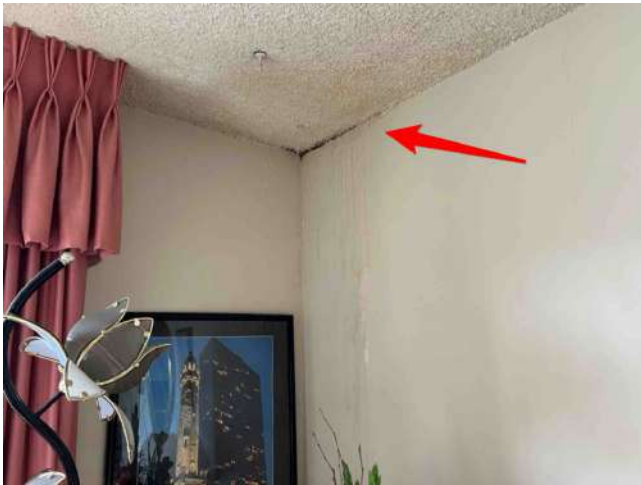
there are areas of moisture stains and damage on the living room ceilings / walls and the main bedroom ceiling / closet ceiling.

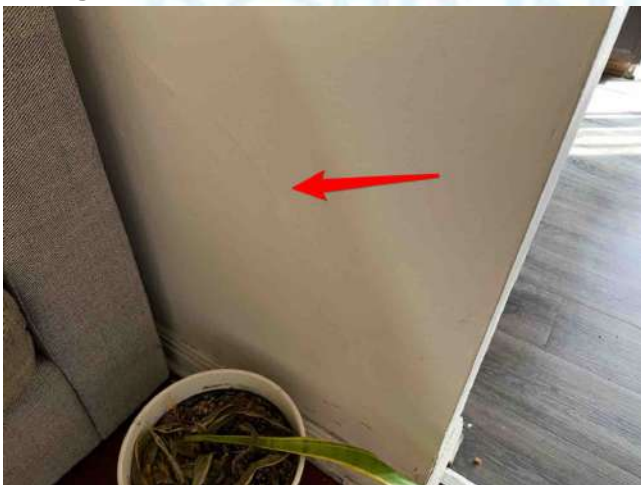
there are areas of moisture stains and damage on the ceilings / walls of the living area, kitchen / dining areas and bathrooms.

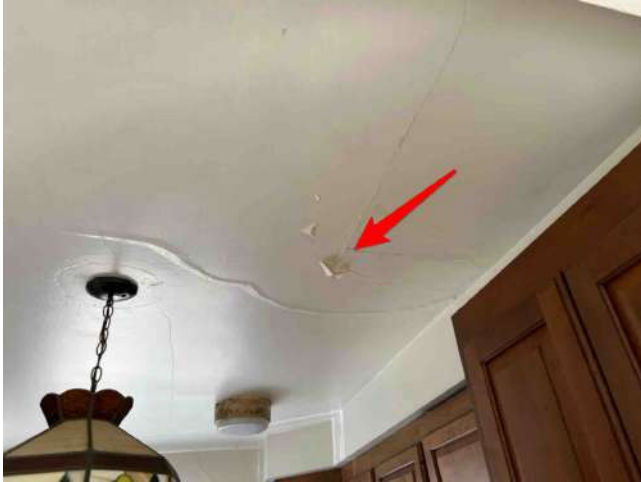
there are areas of moisture stains and damage on the ceilings / walls in the kitchen.

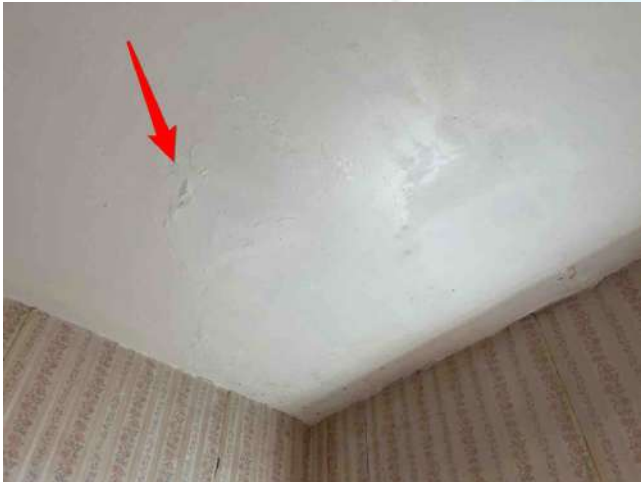
there are areas of moisture stains and damage in the bathrooms.

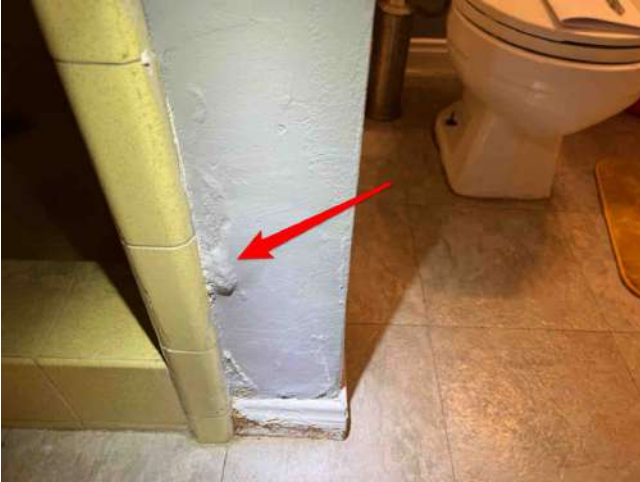
there are areas of moisture stains and damage in the bathrooms walls / ceilings

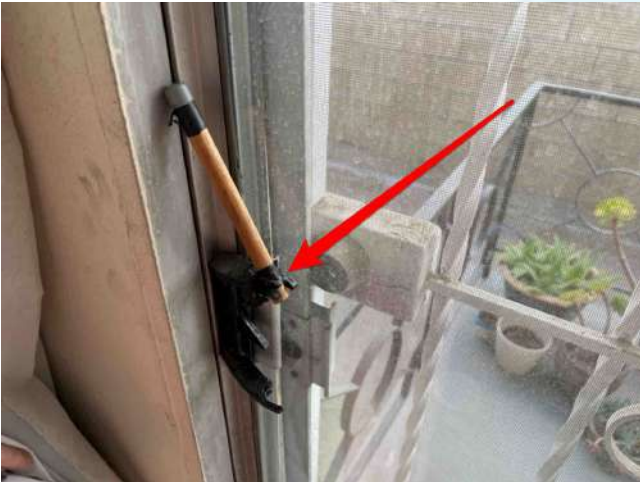
Not Acceptable: The exterior sliders throughout all units are older, worn, hard to slide, have damaged / missing handles and will need general repairs / replacements.

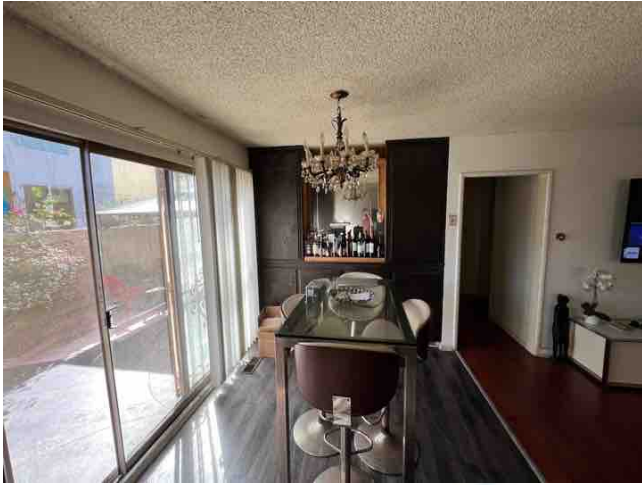
the sliding glass doors do not appear to have tempered glass or a safety film installed on them. Having one or the other reduces the danger of bodily harm should the glass be broken and in some cities is required at the time of sale.

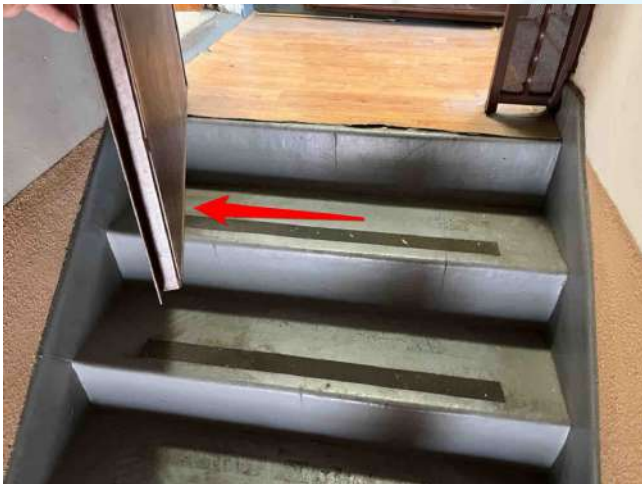
Needs Attention: Security screen doors swing out over the steps which can pose a trip / fall hazard.

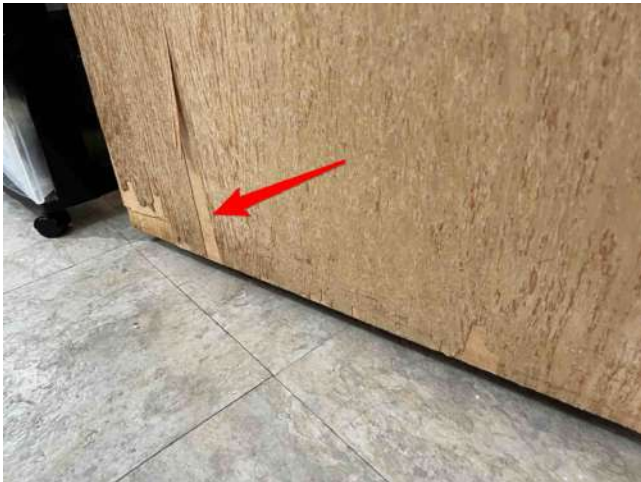
there are interior doors that have some damage at the base, missing or no door stops and that are out of adjustment and could use repair throughout the units.

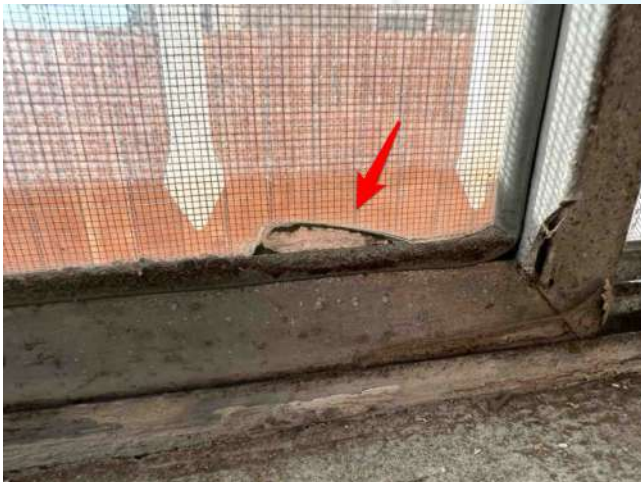
Not Acceptable: there are cracked window panes in areas and such as at unit 2 and unit 5.

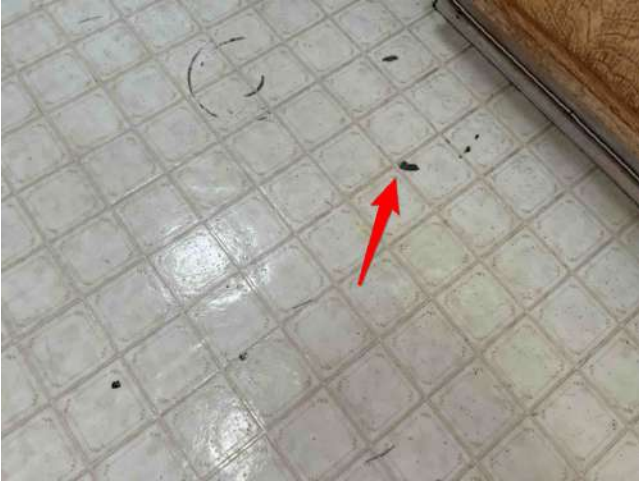
Needs Attention: The flooring is worn / stained throughout and will need carpet replacements and wood or vinyl repairs / refinishing throughout all the units.

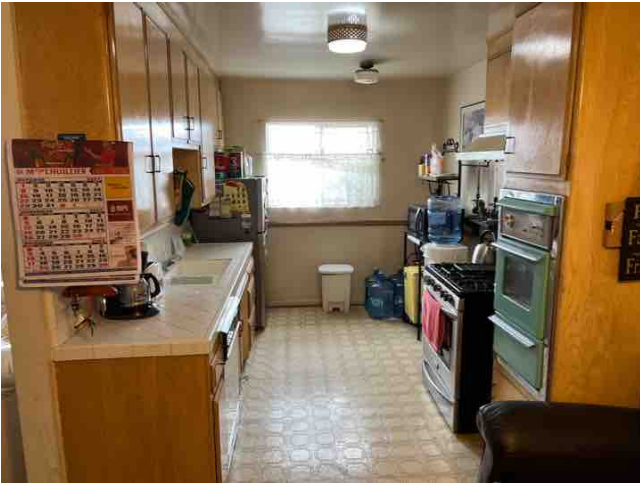
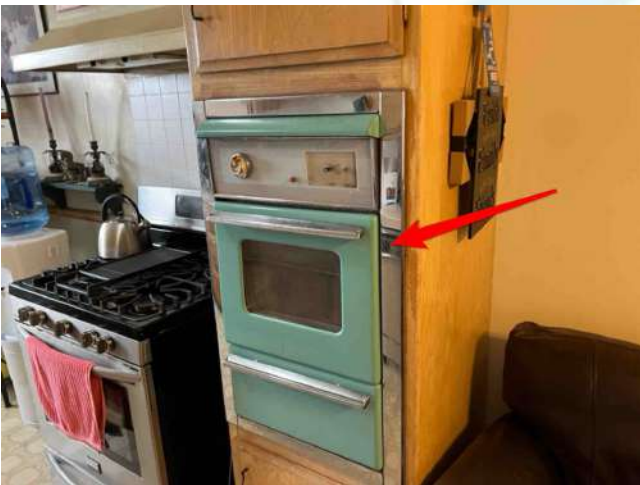
Needs Attention: damaged tile on counter.

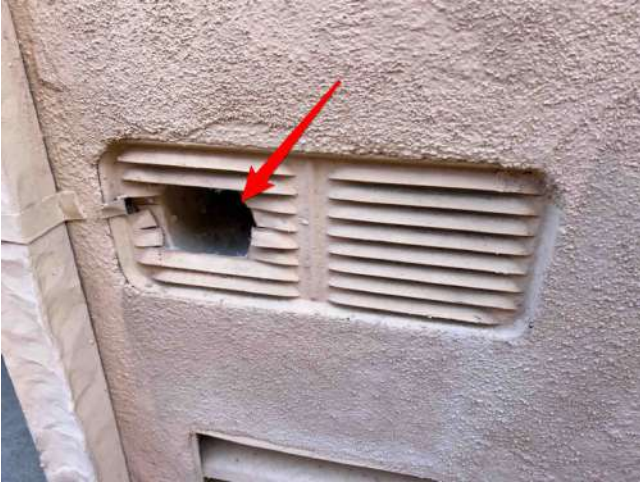
Needs Attention: the exterior dryer vent cover is damaged / missing.

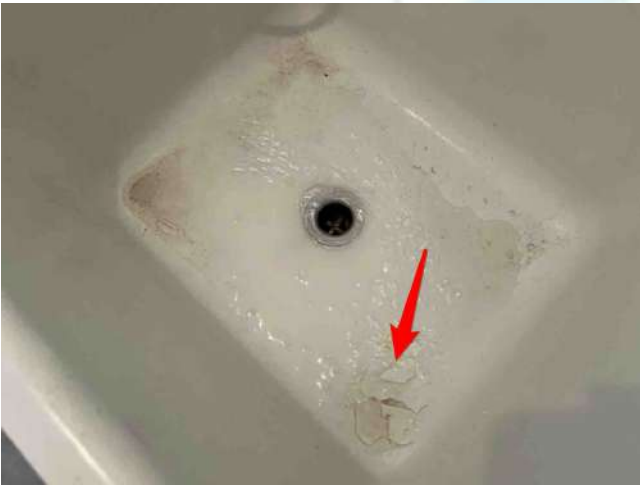
Needs Attention: the sink surface is worn and peeling.

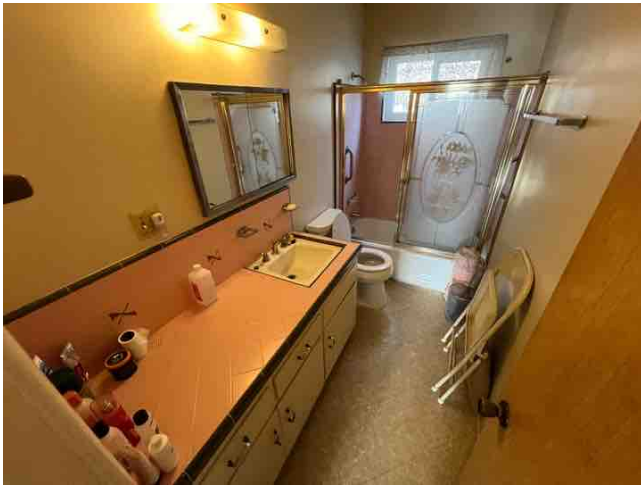
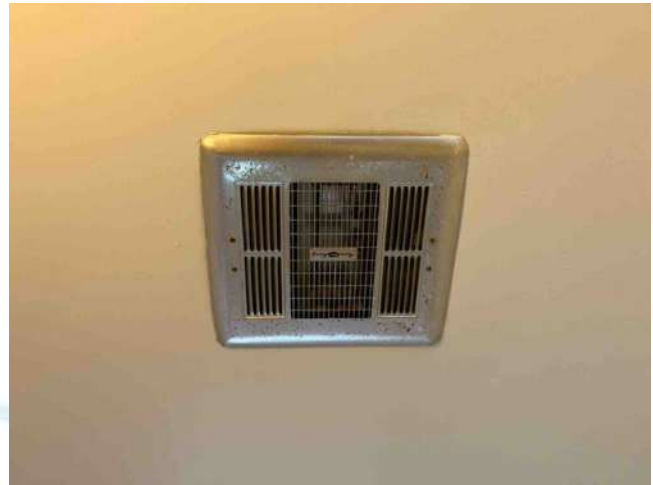
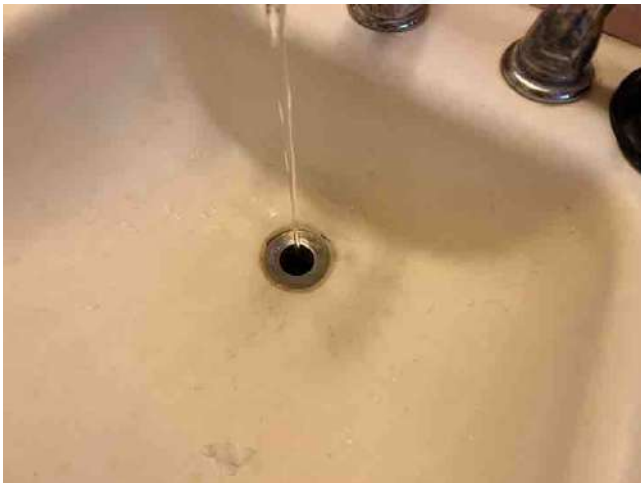
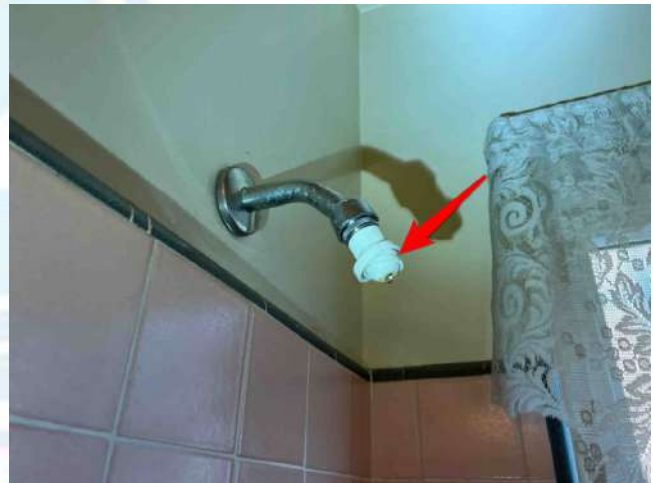
Unit 1 hallway with tub / shower combo.

Needs Attention: The shower grout is stained and worn.

Needs Attention: The vent light is not working and the switch is loose.

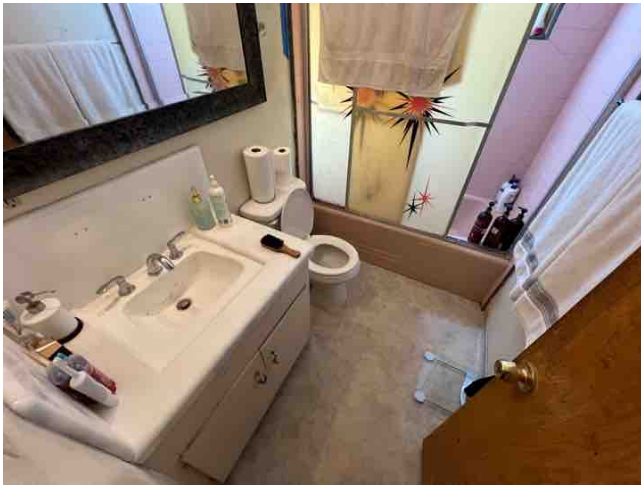
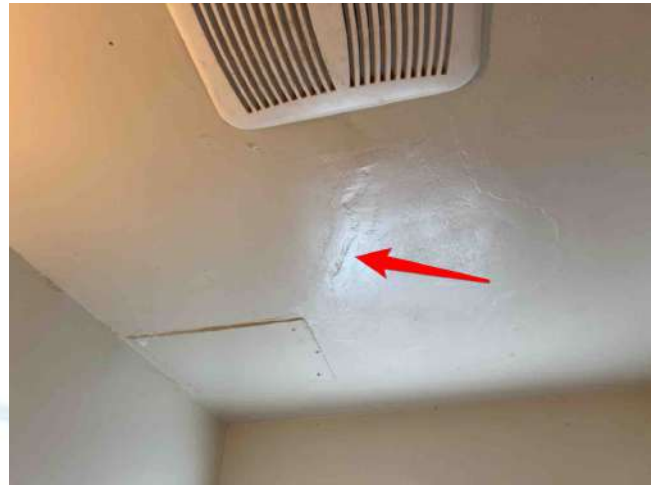
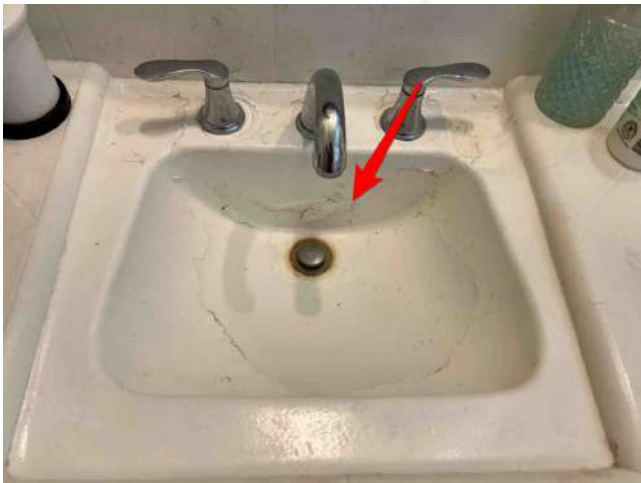
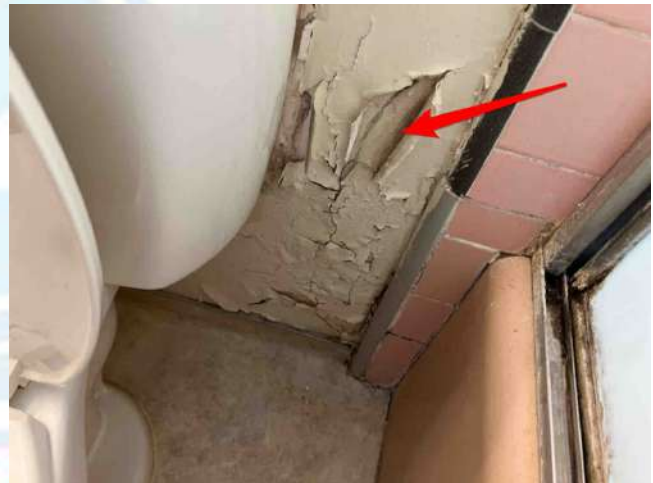
Unit 2 hallway with tub / shower combo.

There is moisture damage on the walls / ceilings.

Needs Attention: The sink is loose at the wall.

Not Acceptable: The toilet is running continuously, is noisy and the bolts are rusted as from leaks.

The toilet is loose and not properly attached to the floor. It needs to be properly bolted down.

Needs Attention: The shower tile has cracked tile and deteriorated grout.

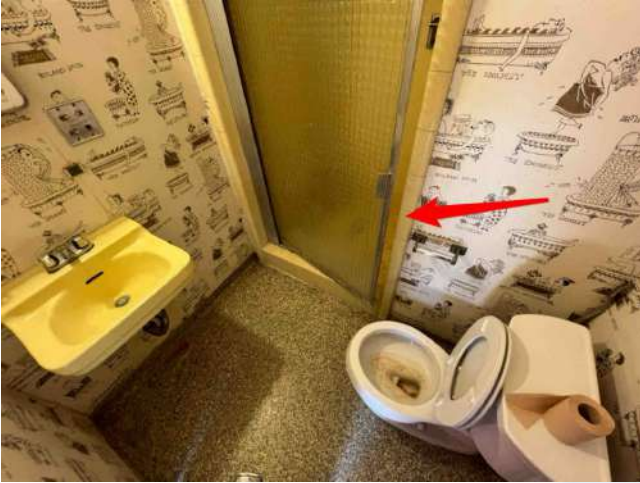
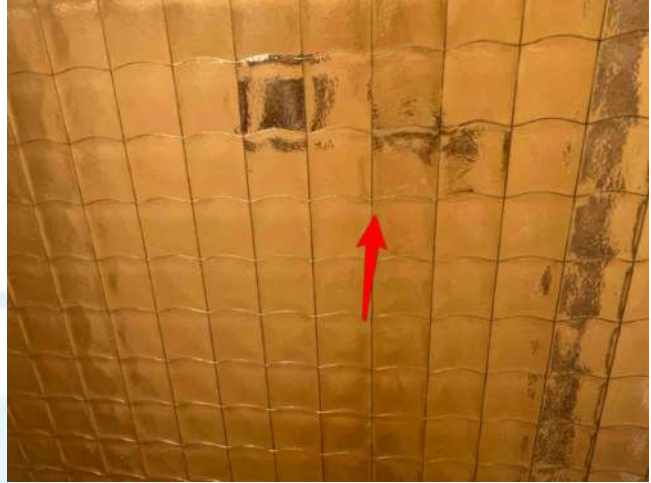
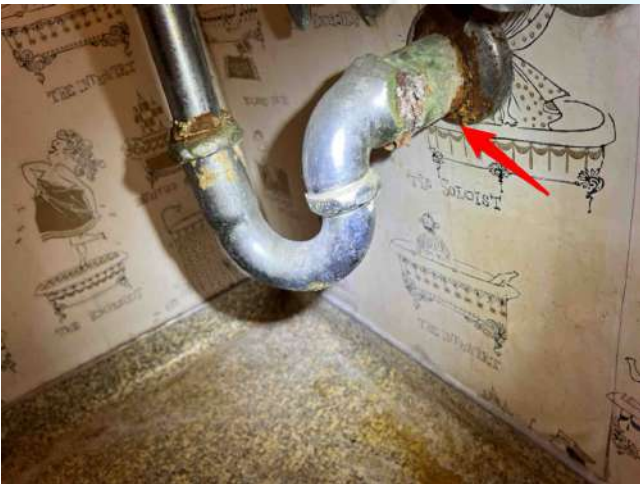
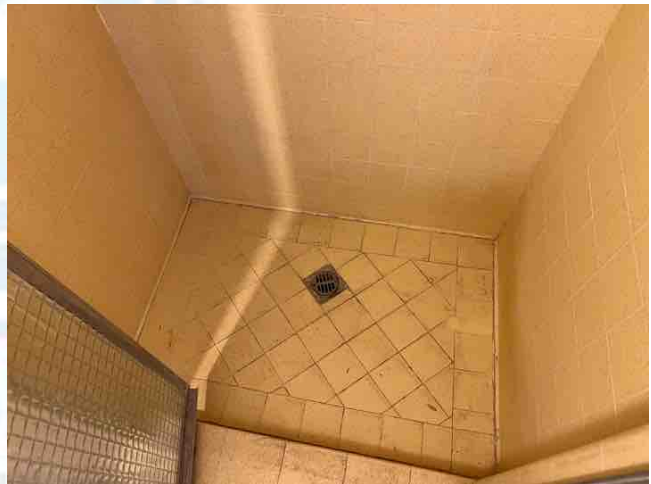
Unit 3 with shower only.

There is moisture damage on the walls and ceilings.

The cabinets have areas of damage.

Needs Attention: The sink is worn and peeling.

Not Acceptable: The floor is soft / damaged around the toilet as from leaks at the toilet area.

Needs Attention: The tub and shower fixtures are worn and corroded.

Needs Attention: There is cracked tile and deteriorated grout in the shower.

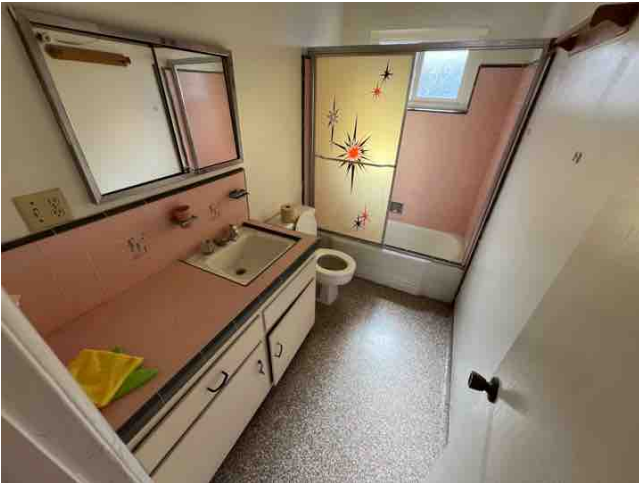
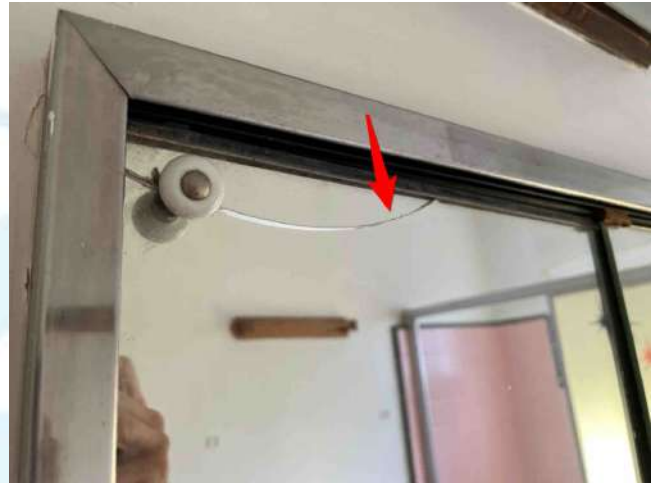
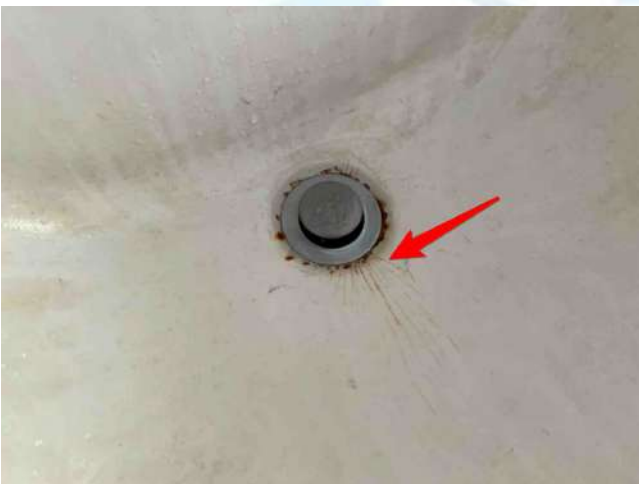
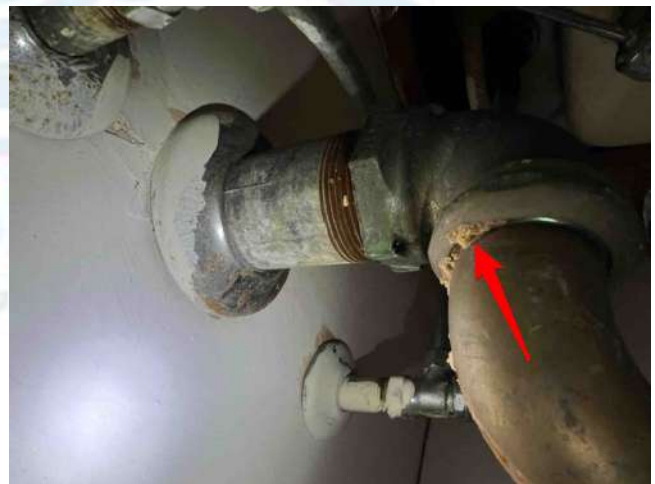
Unit 3 hallway with tub / shower combo.

The drain has some corrosion / rust in areas.

Not Acceptable: The toilet supply has staining under it and may be leaking.

The shower has areas of deteriorated grout.

The shower enclosure is an older style of 'safety' glass, this is no longer considered safe by today's standards and replacement with a tempered glass enclosure is advised for safety, this would be an upgrade.

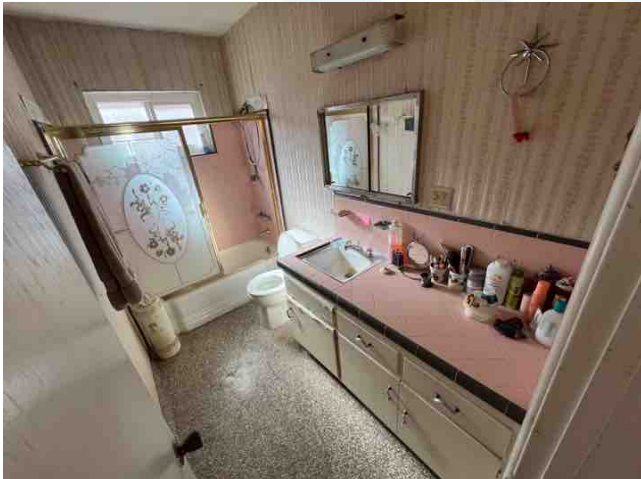
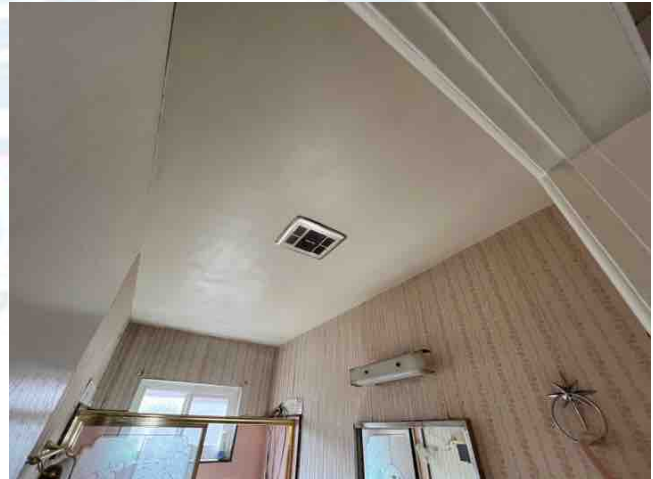
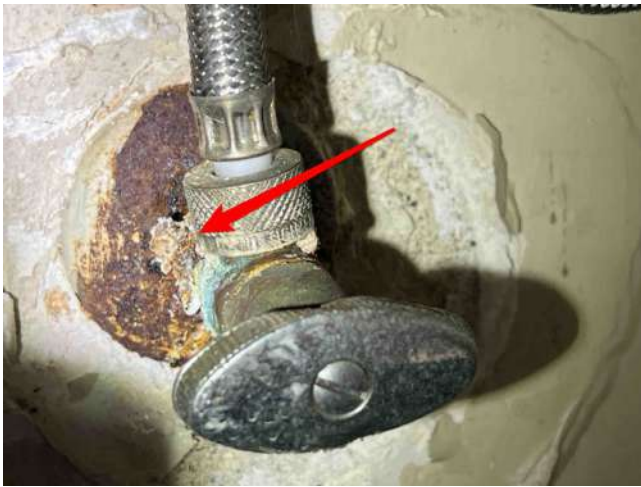
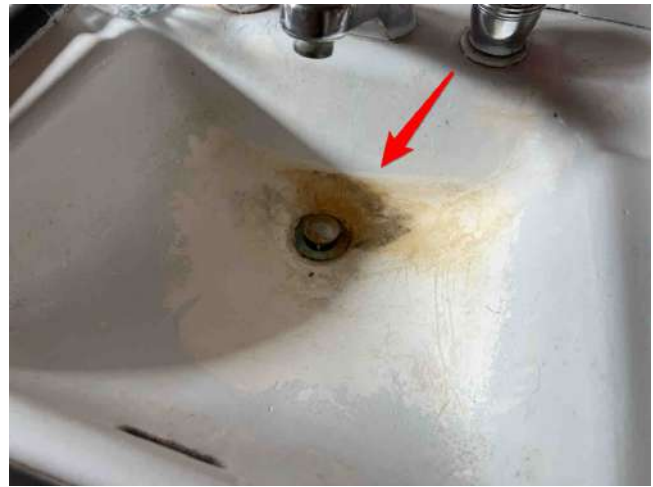
Unit 4 hall with tub / shower combo

There is moisture damage at the shower.

Needs Attention: The sink is cracked and rusted.

The drain has some corrosion / rust in areas.

The mirror is cracked.

Not Acceptable: The handles leak.

The shower has areas of deteriorated grout.

Needs Attention: Half the enclosure door is missing.

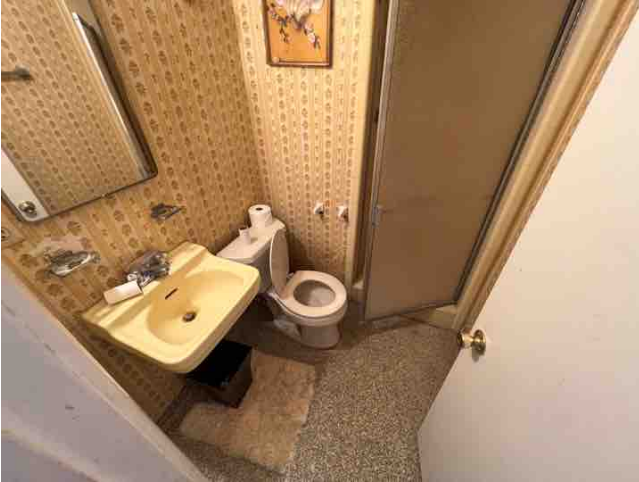
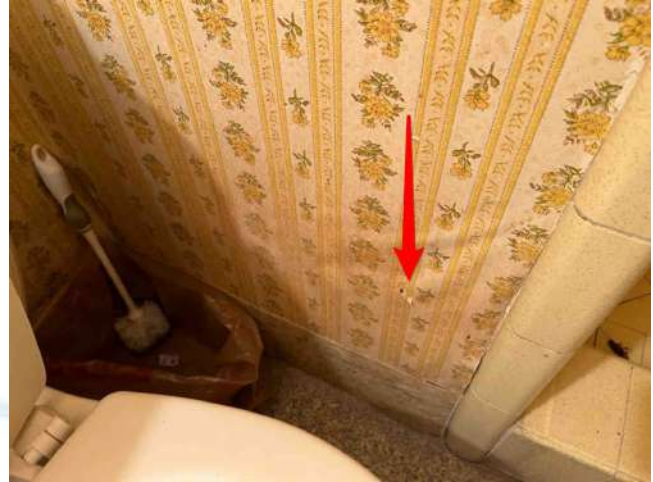
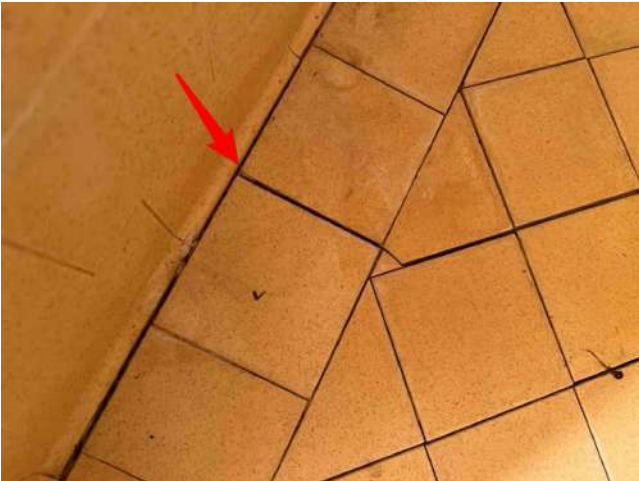
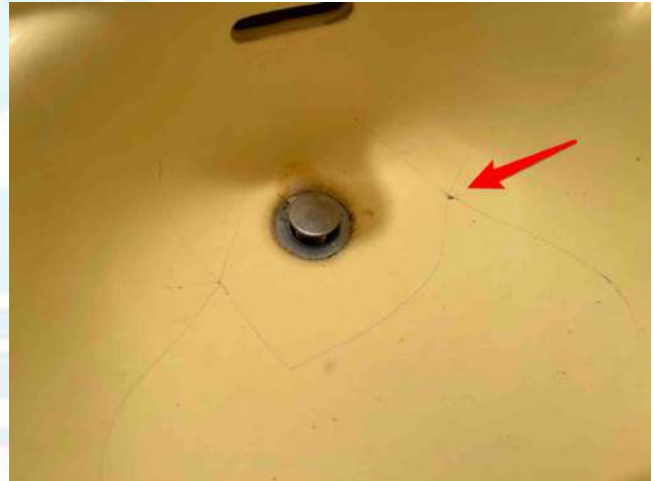
Unit 4 hallway with shower only.

There is moisture damage on the ceiling and the wall paper is peeling in the walls.

The cabinet(s) below the sink have areas of staining.

There's some corrosion to the supply lines under the sink.

Needs Attention: The sink is worn and deteriorated.

Not Acceptable: The drain is leaking and has a note on the sink not to use it.

The drain has some corrosion / rust in areas.

Needs Attention: The handles leak during use.

Needs Attention: The shower wall have cracked tile and deteriorated grout.

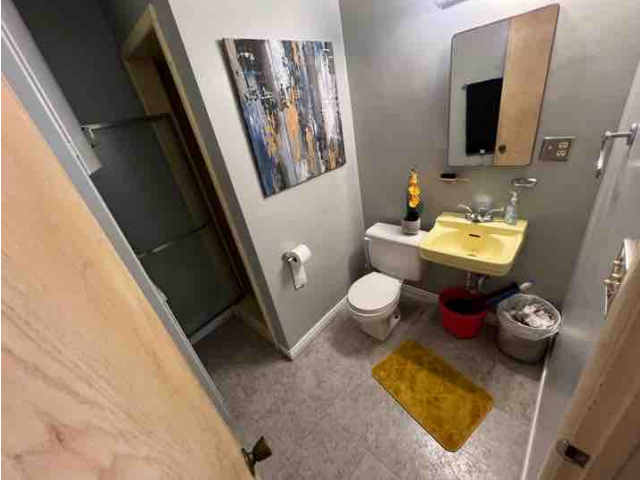
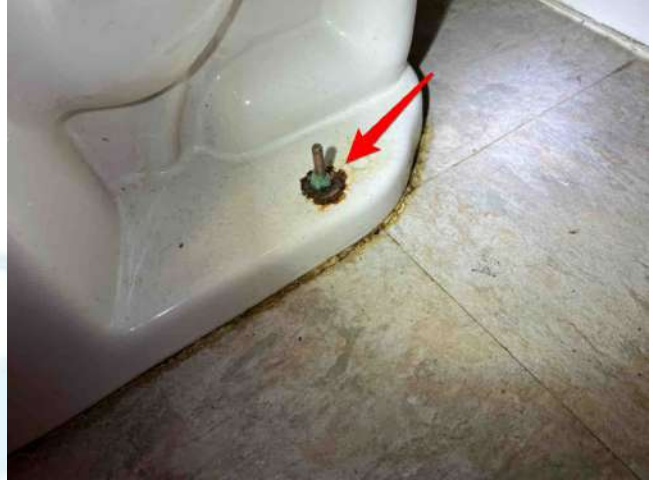
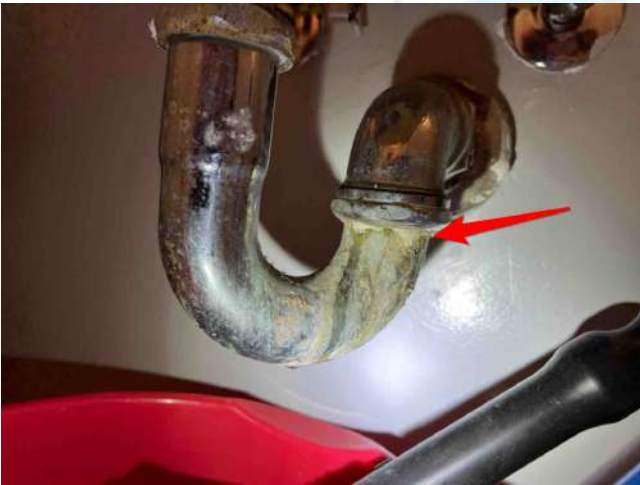
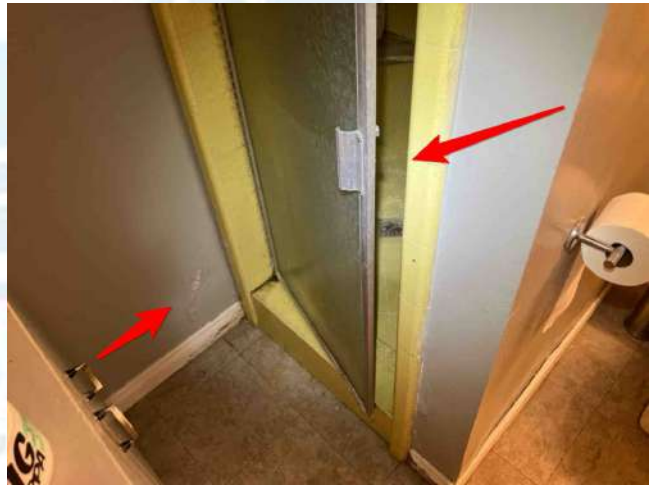
Unit 5 hallway with shower only.

There is moisture damage near the shower.

The bathroom sink is cracked.

Not Acceptable: The shower walls have large areas of damaged and deteriorated grout.

Needs Attention: The enclosure sticks and will need repairs.

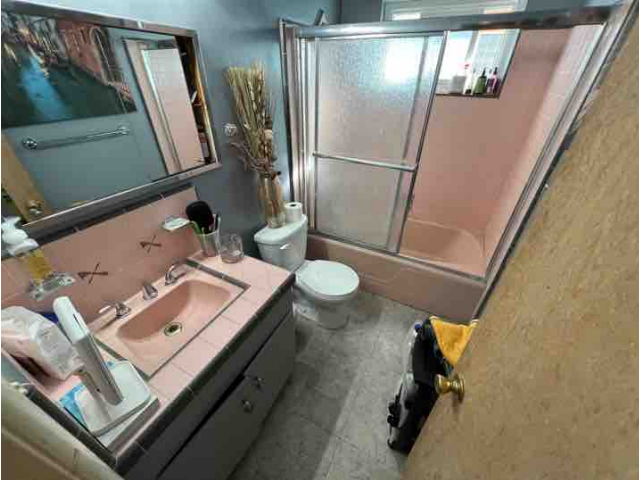
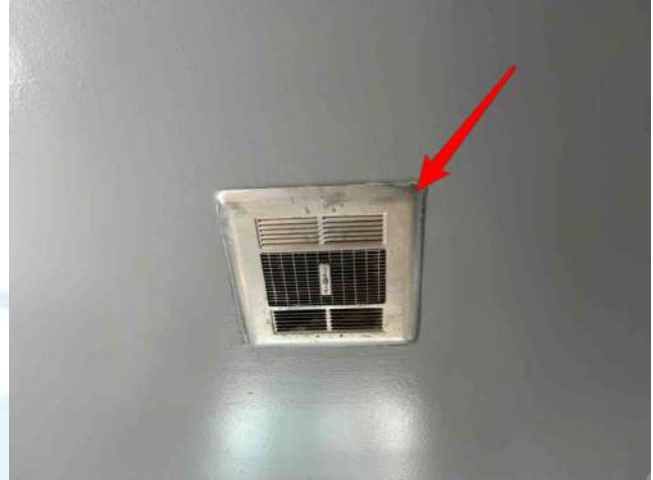
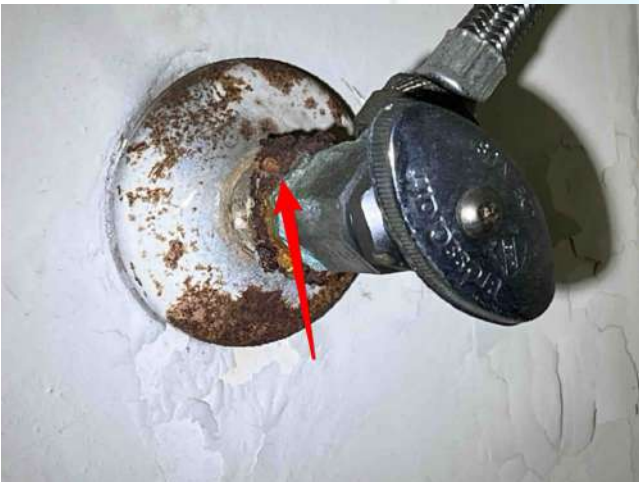
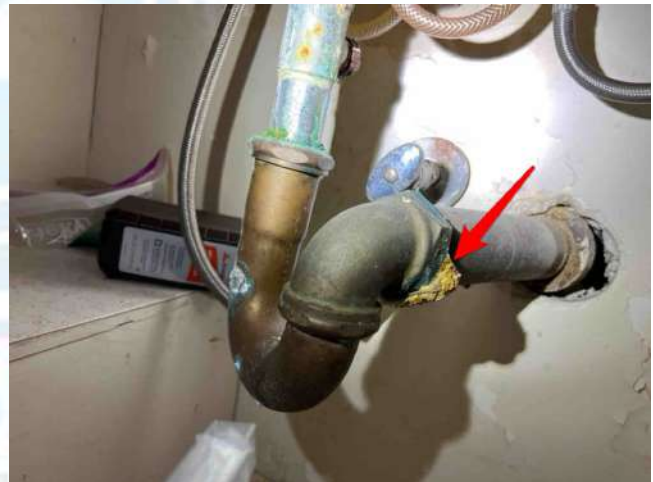
Unit 5 hallway with tub / shower combo.

There is moisture damage on the wall outside the shower

Needs Attention: The drain is rusted / worn.

Needs Attention: The bolts are rusted as from leaks at the toilet area.

Needs Attention: The shower walls have cracked tile and deteriorated grout.
