LUX Fireplace Inspections

Wednesday, June 12, 2024
Vincent Marshal
1616 Linda Rosa
Los Angeles, California 90041

Living Room

Living Room Mason Fireplace

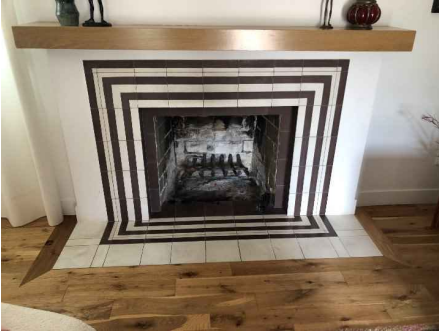
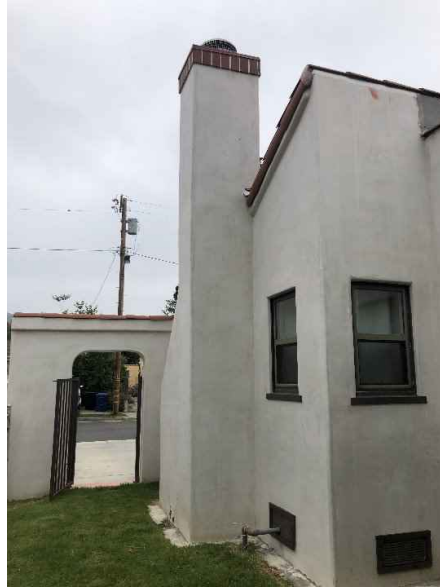
3: SUMMARY:**FINAL RECOMMENDATION:****DO NOT USE YOUR FIREPLACE/PLEASE SEE FINAL RECOMMENDATION.**

It is required to rebuild your fireplace/chimney from the shoulder up. You can reference the Information Bulletin on RECONSTRUCTION AND REPLACEMENT OF EARTHQUAKE DAMAGED MASONRY CHIMNEYS put forward by The City of Los Angeles Department of Building and Safety must be followed. If you are not in Los Angeles County you should consult with the local Authority Having Jurisdiction (AHJ) requirements for rebuilding a masonry chimney. The information bulletin put forward by Los Angeles County should be an acceptable option in all counties. In addition, all recommendations in the above fireplace should be completed prior to using the chimney.
